**Barton Fields Further Surveys
Bat Building Survey**

January 2010

Client	Oxford City Council
Job Name	Barton Fields Further Surveys
Report title	Bat Building Survey
File reference	2755 02_X001_bat_rep_FINAL_EAHEKG_240110

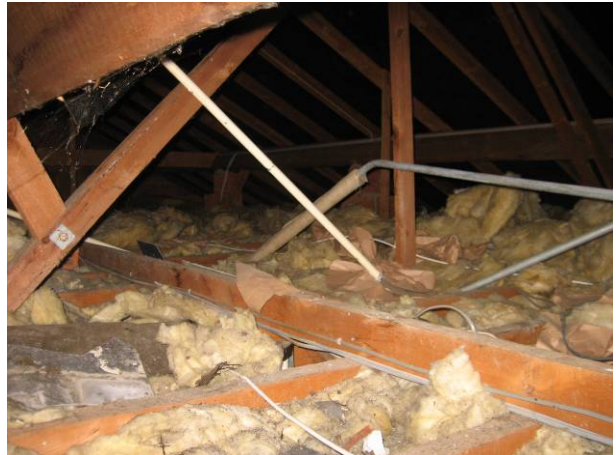
Figure D: Attic floor showing pipes and insulation

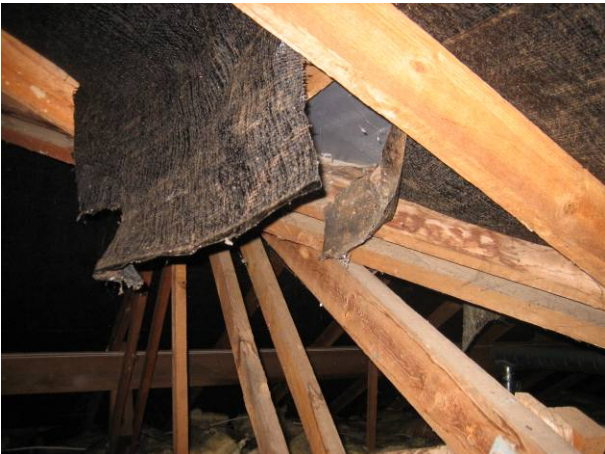
Figure E: Loose hanging felt inside northern roof section

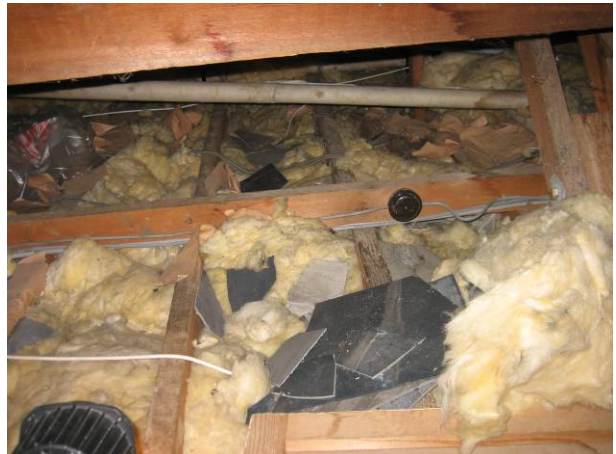
The presence of broken asbestos roofing tiles close to the hatch in the central part of the building (see Figure 1) meant that full access to the roof space from this hatch could not be gained for health and safety reasons. Entering the roof via this hatch would have required climbing over the tiles with an associated risk of disturbing dust that could contain asbestos or breaking the tiles further. However, an inspection of this area was made from the hatch using a torch as far as was possible and all other areas of roof-space were accessed fully. Nevertheless, this constraint presents some limitations on the assessment as not all areas could be searched thoroughly. Recommendations are given with this in mind.

Figure F: Broken asbestos roofing tiles inside northern roof hatch

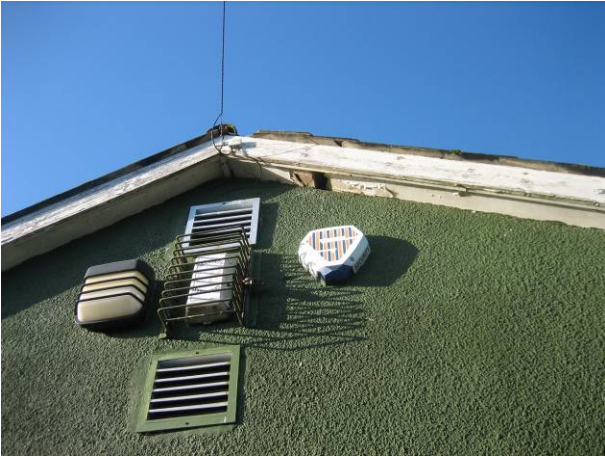
Externally, the roof is surrounded by boxed soffits constructed from wood. Ten holes of differing sizes were recorded within the soffits at various places around the roof (see Figure 1). Daylight could be seen entering the roof-space through these holes from the inside. In addition, daylight was seen entering through gaps under the roof tiles themselves. From the outside, it could be seen that the ridge tiles in one area in the north-west part of the building (see Figure 1) had been replaced by lead flashing which had become loose. Lead flashing was also present at the roof join toward the centre of the building and at the southern end of the building (see Figure 1). Despite gaps and holes, the roof was found to be uniformly dry inside, although fairly draughty and open.

Figure G: Holes into soffit board and vents at gable end

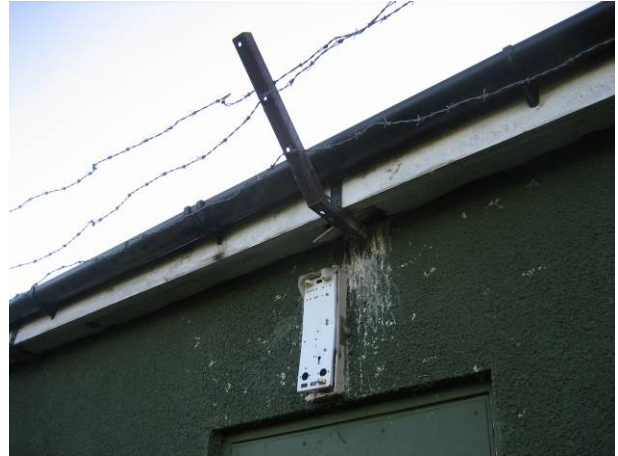
Figure H: Well-used bird roost at soffit hole with build-up of droppings

To avoid the risk of damaging or destroying active nests and eggs or killing or injuring nesting birds, it is recommended that any demolition or structural works affecting the pavilion building is undertaken outside the main breeding season of most bird species. In practice, works should be

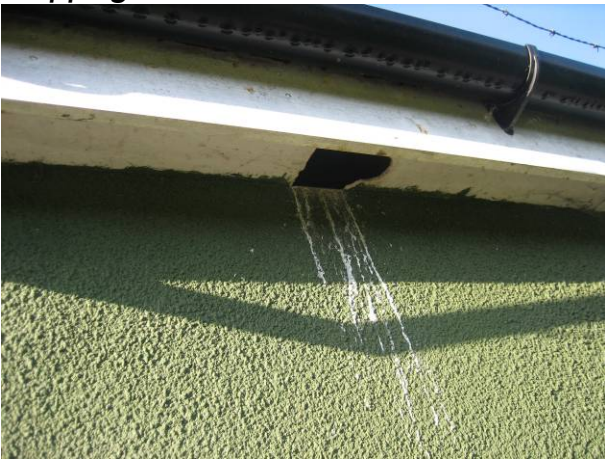
Figure I: Hole in soffit board, also with bird droppings

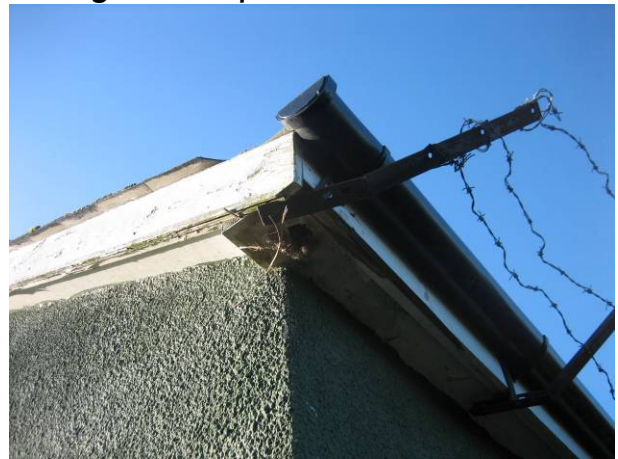
It was noted during the survey that parts of the roof have been used as a nesting site by birds. Damage and destruction of bird's nests or eggs could therefore occur if works are undertaken on the building when nests might be in use. In practice, it is unlikely that adult birds would be at risk of killing or injury as they are alert and highly mobile. However, there is a chance that birds could be killed or injured if they became trapped inside the building prior to demolition or major structural works. Young birds and nestlings would be at much higher risk of killing or injury during such activities as they may be unable to move away from danger.

Figure J: Hole in soffit board with old bird nesting material present

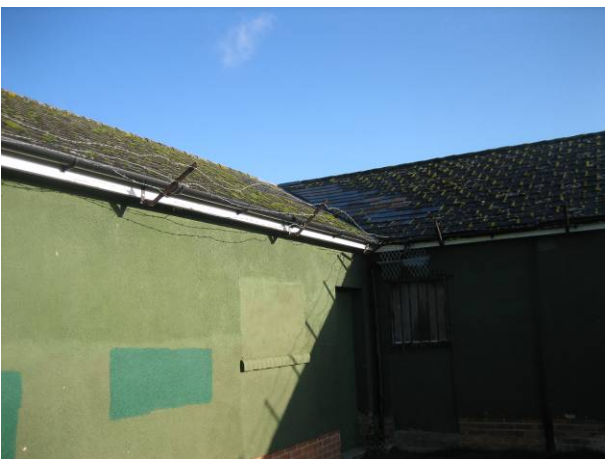
Figure K: Lead flashing at roof join

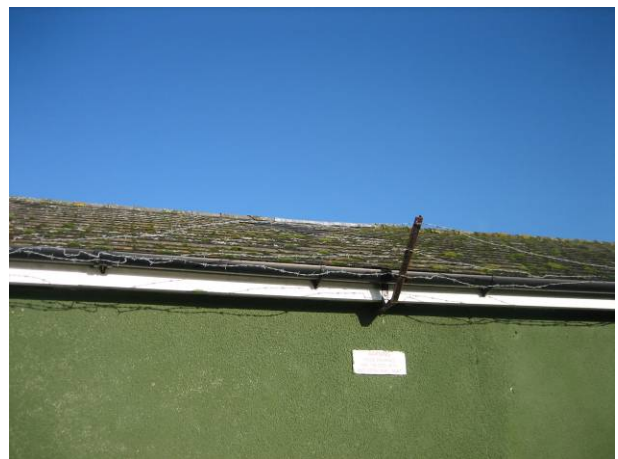
Figure L: Loose lead flashing along ridge at north-west end of roof
