**Barton Fields, Oxford  
Further Bat and Badger Surveys 2010**

Final  
Rev 1

<b>Client</b>	Oxford City Council
<b>Job Name</b>	Barton Fields, Oxford
<b>Report title</b>	Further Bat and Badger Surveys 2010
<b>File reference</b>	2755.03_X001_rep_eahe_171010

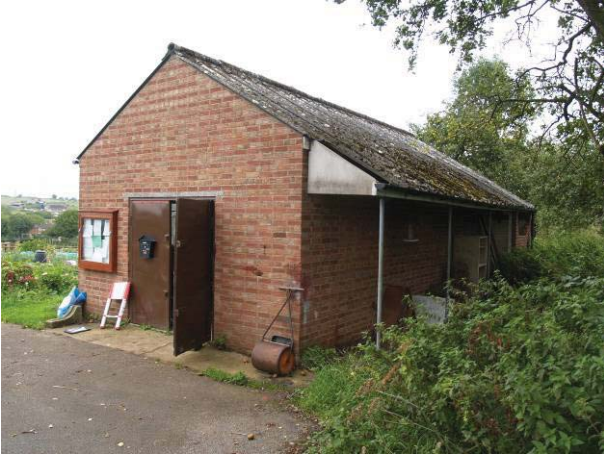
**Figure A: Allotment building – south-east aspect**

The building located within the allotment area is single storey and of solid brick-wall construction with a pitched corrugated asbestos roof (see Figure A and B; Appendix 1).

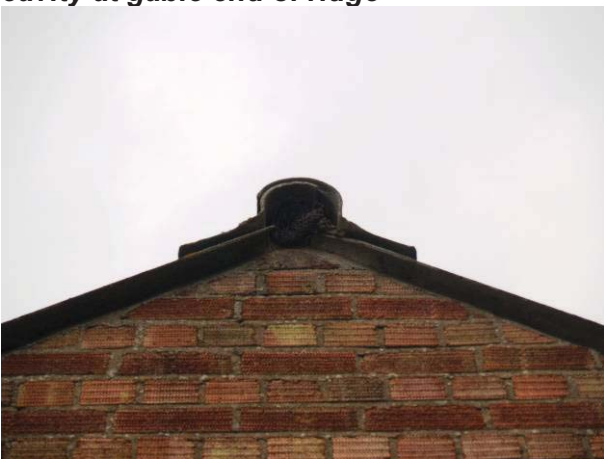
**Figure C: Allotment building – blocked cavity at gable end of ridge**

Externally, barge boarding is present although this was found to be well-sealed and fitted flush with the walls (Figure D; Appendix 1). The ridge tiling of the roof also appears to be asbestos; an opening at both ends of the ridge has been filled by chicken wire and other items, e.g. a small wheel (Figure C; Appendix 1).

No evidence of roosting bats was found anywhere within this building. Potential access into the building for bats is limited to the opening on the ridge of the roof at the apex. However, as these are presently sealed with various materials they are unlikely to be usable by bats in their current state. Furthermore, no obvious cavities that could offer potential roosting sites for bats were identified within the building.

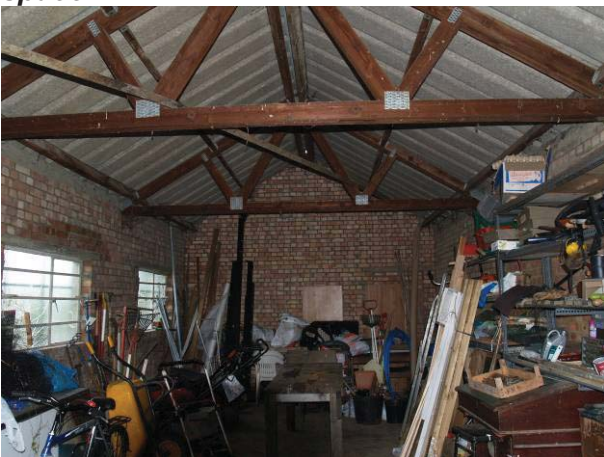
**Figure E: Allotment building – internal space**

Internally, the building is open from floor to apex, with around 4m from floor to apex; the building is around 11m long and 5m wide and consists of a single open space accessed via two large metal doors (Figure E; Appendix 1). Three windows are present along the north-facing wall; these are fitted with security grills. The roof has a modified modern truss structure with closely paired trusses linked by wooden rafters (Figure F; Appendix 1). Asbestos roofing material is secured to the eaves with cement. At present the building is used for the storage of gardening tools and equipment and also as a small office space used by the allotment committee.

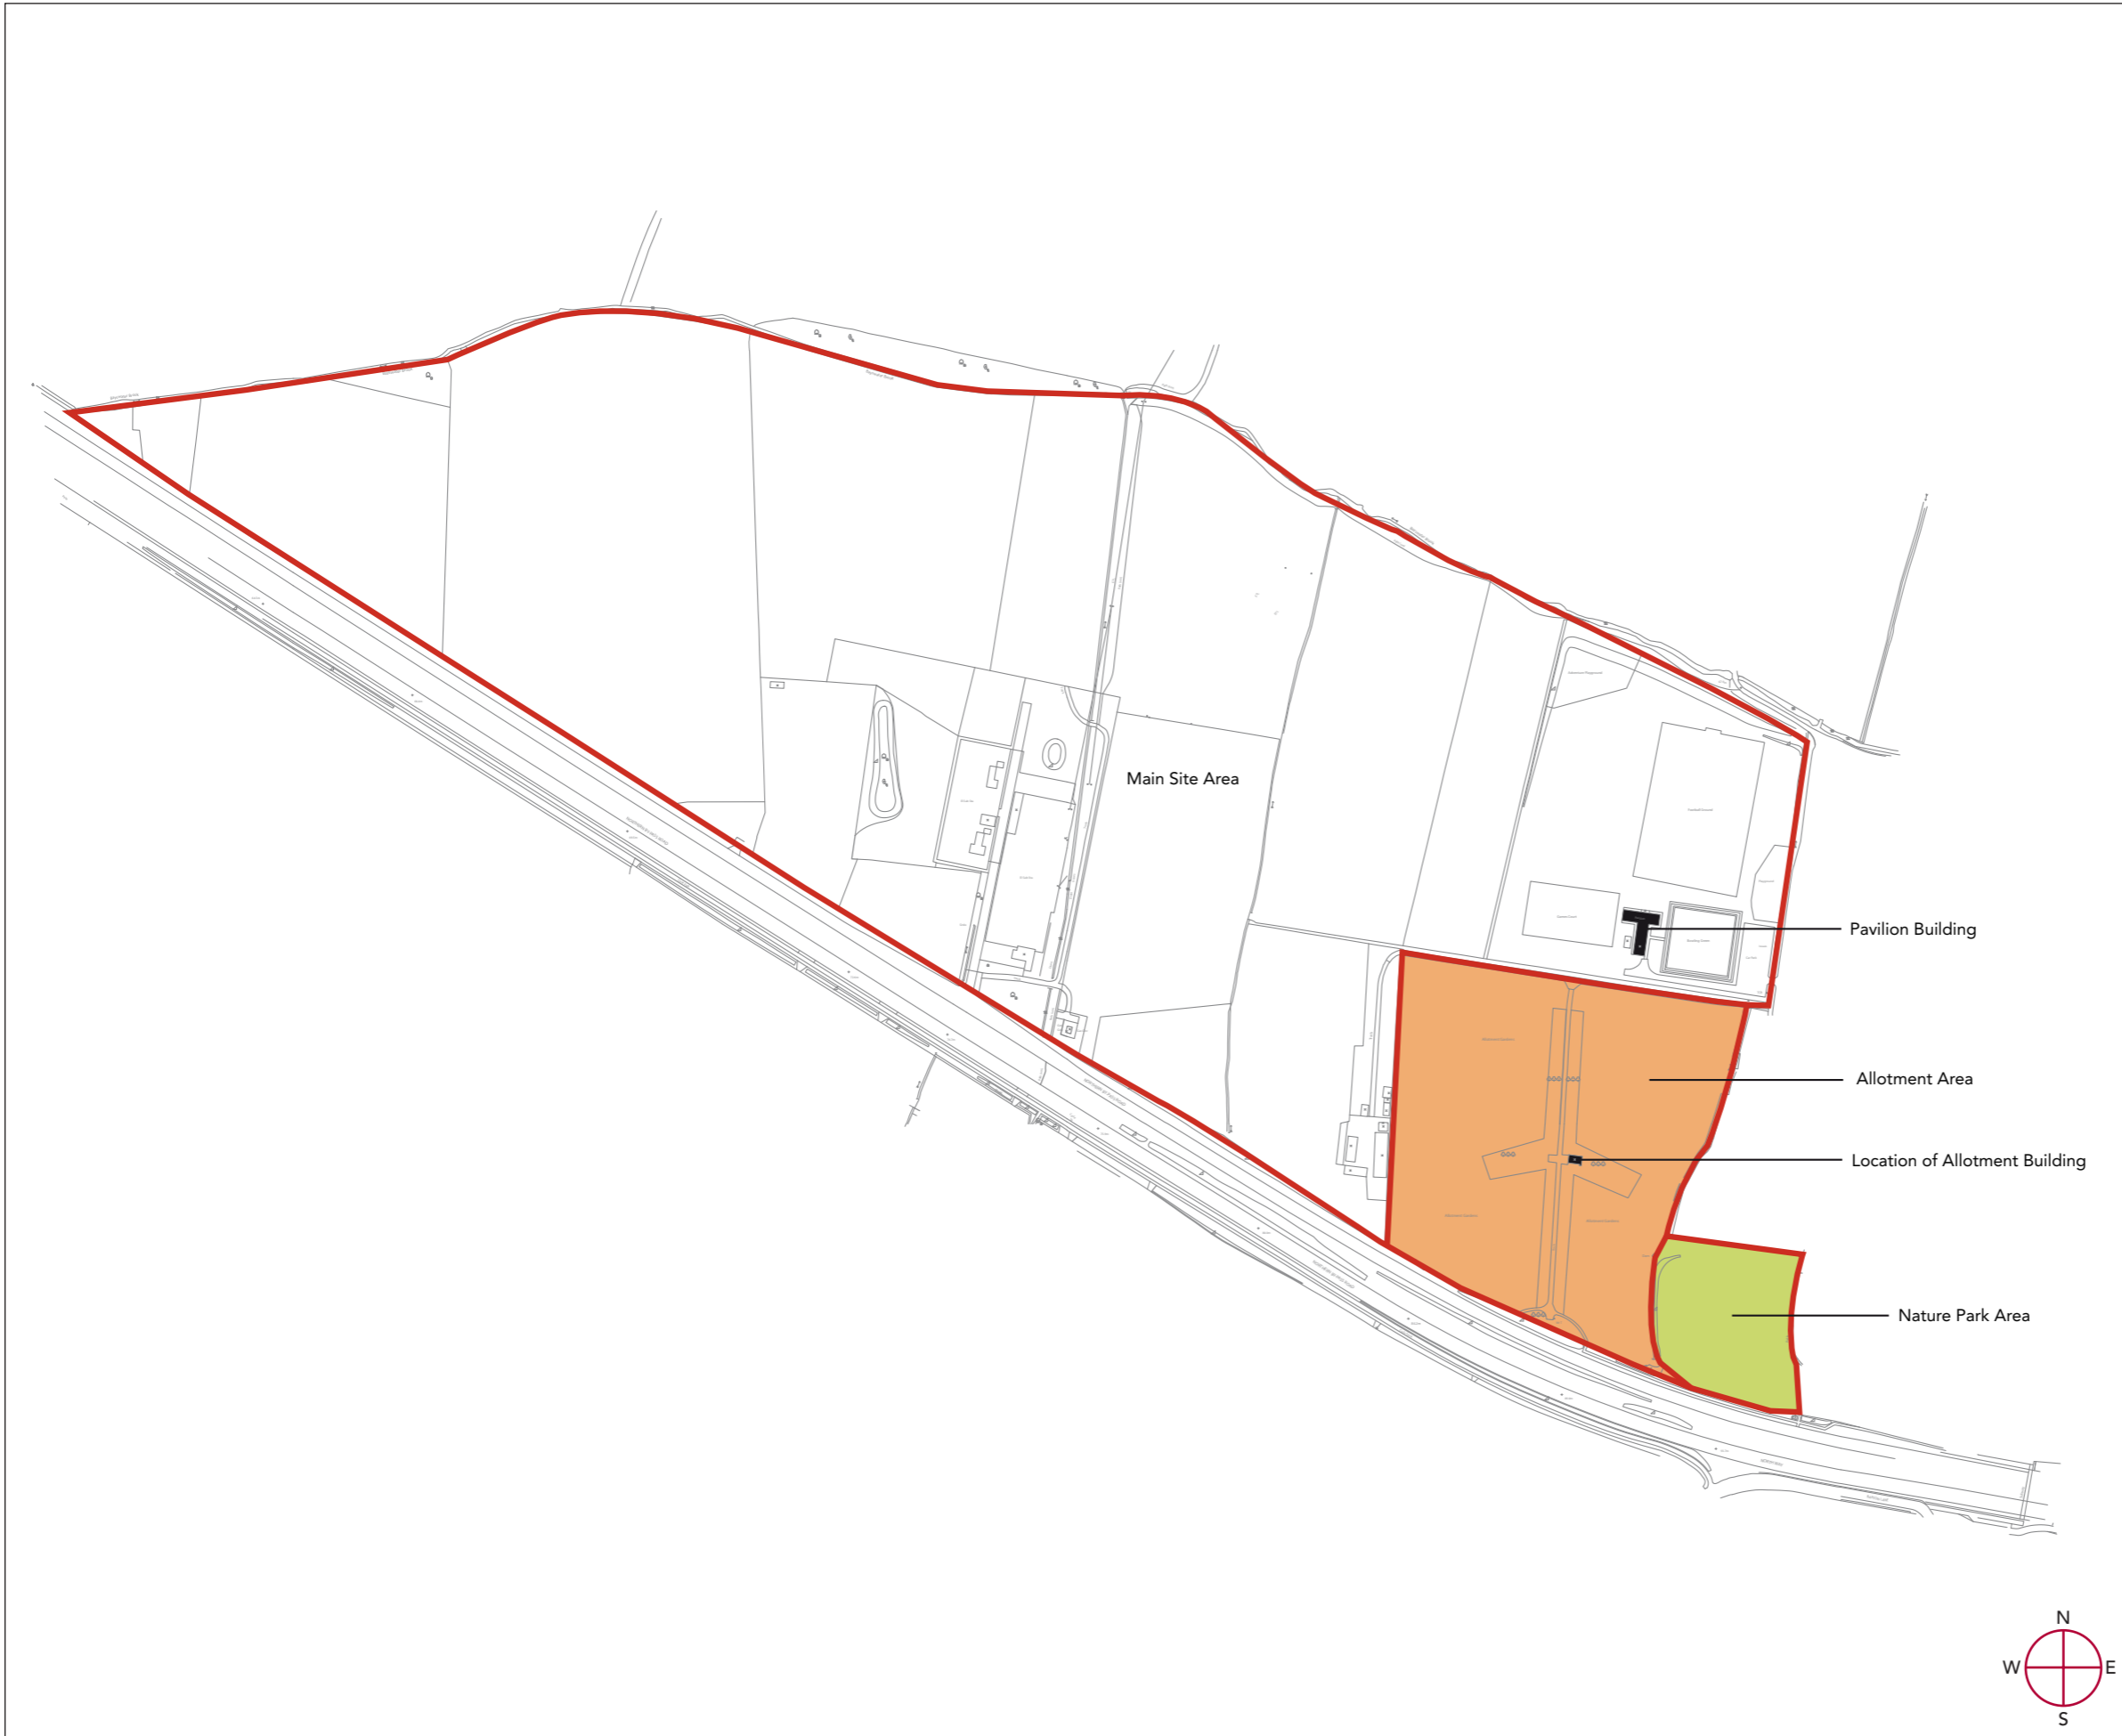
Pavilion Building

Allotment Area

Location of Allotment Building

Approximate path of bat flight lines observed
-

Uncertain origin of bat flight lines observed
-

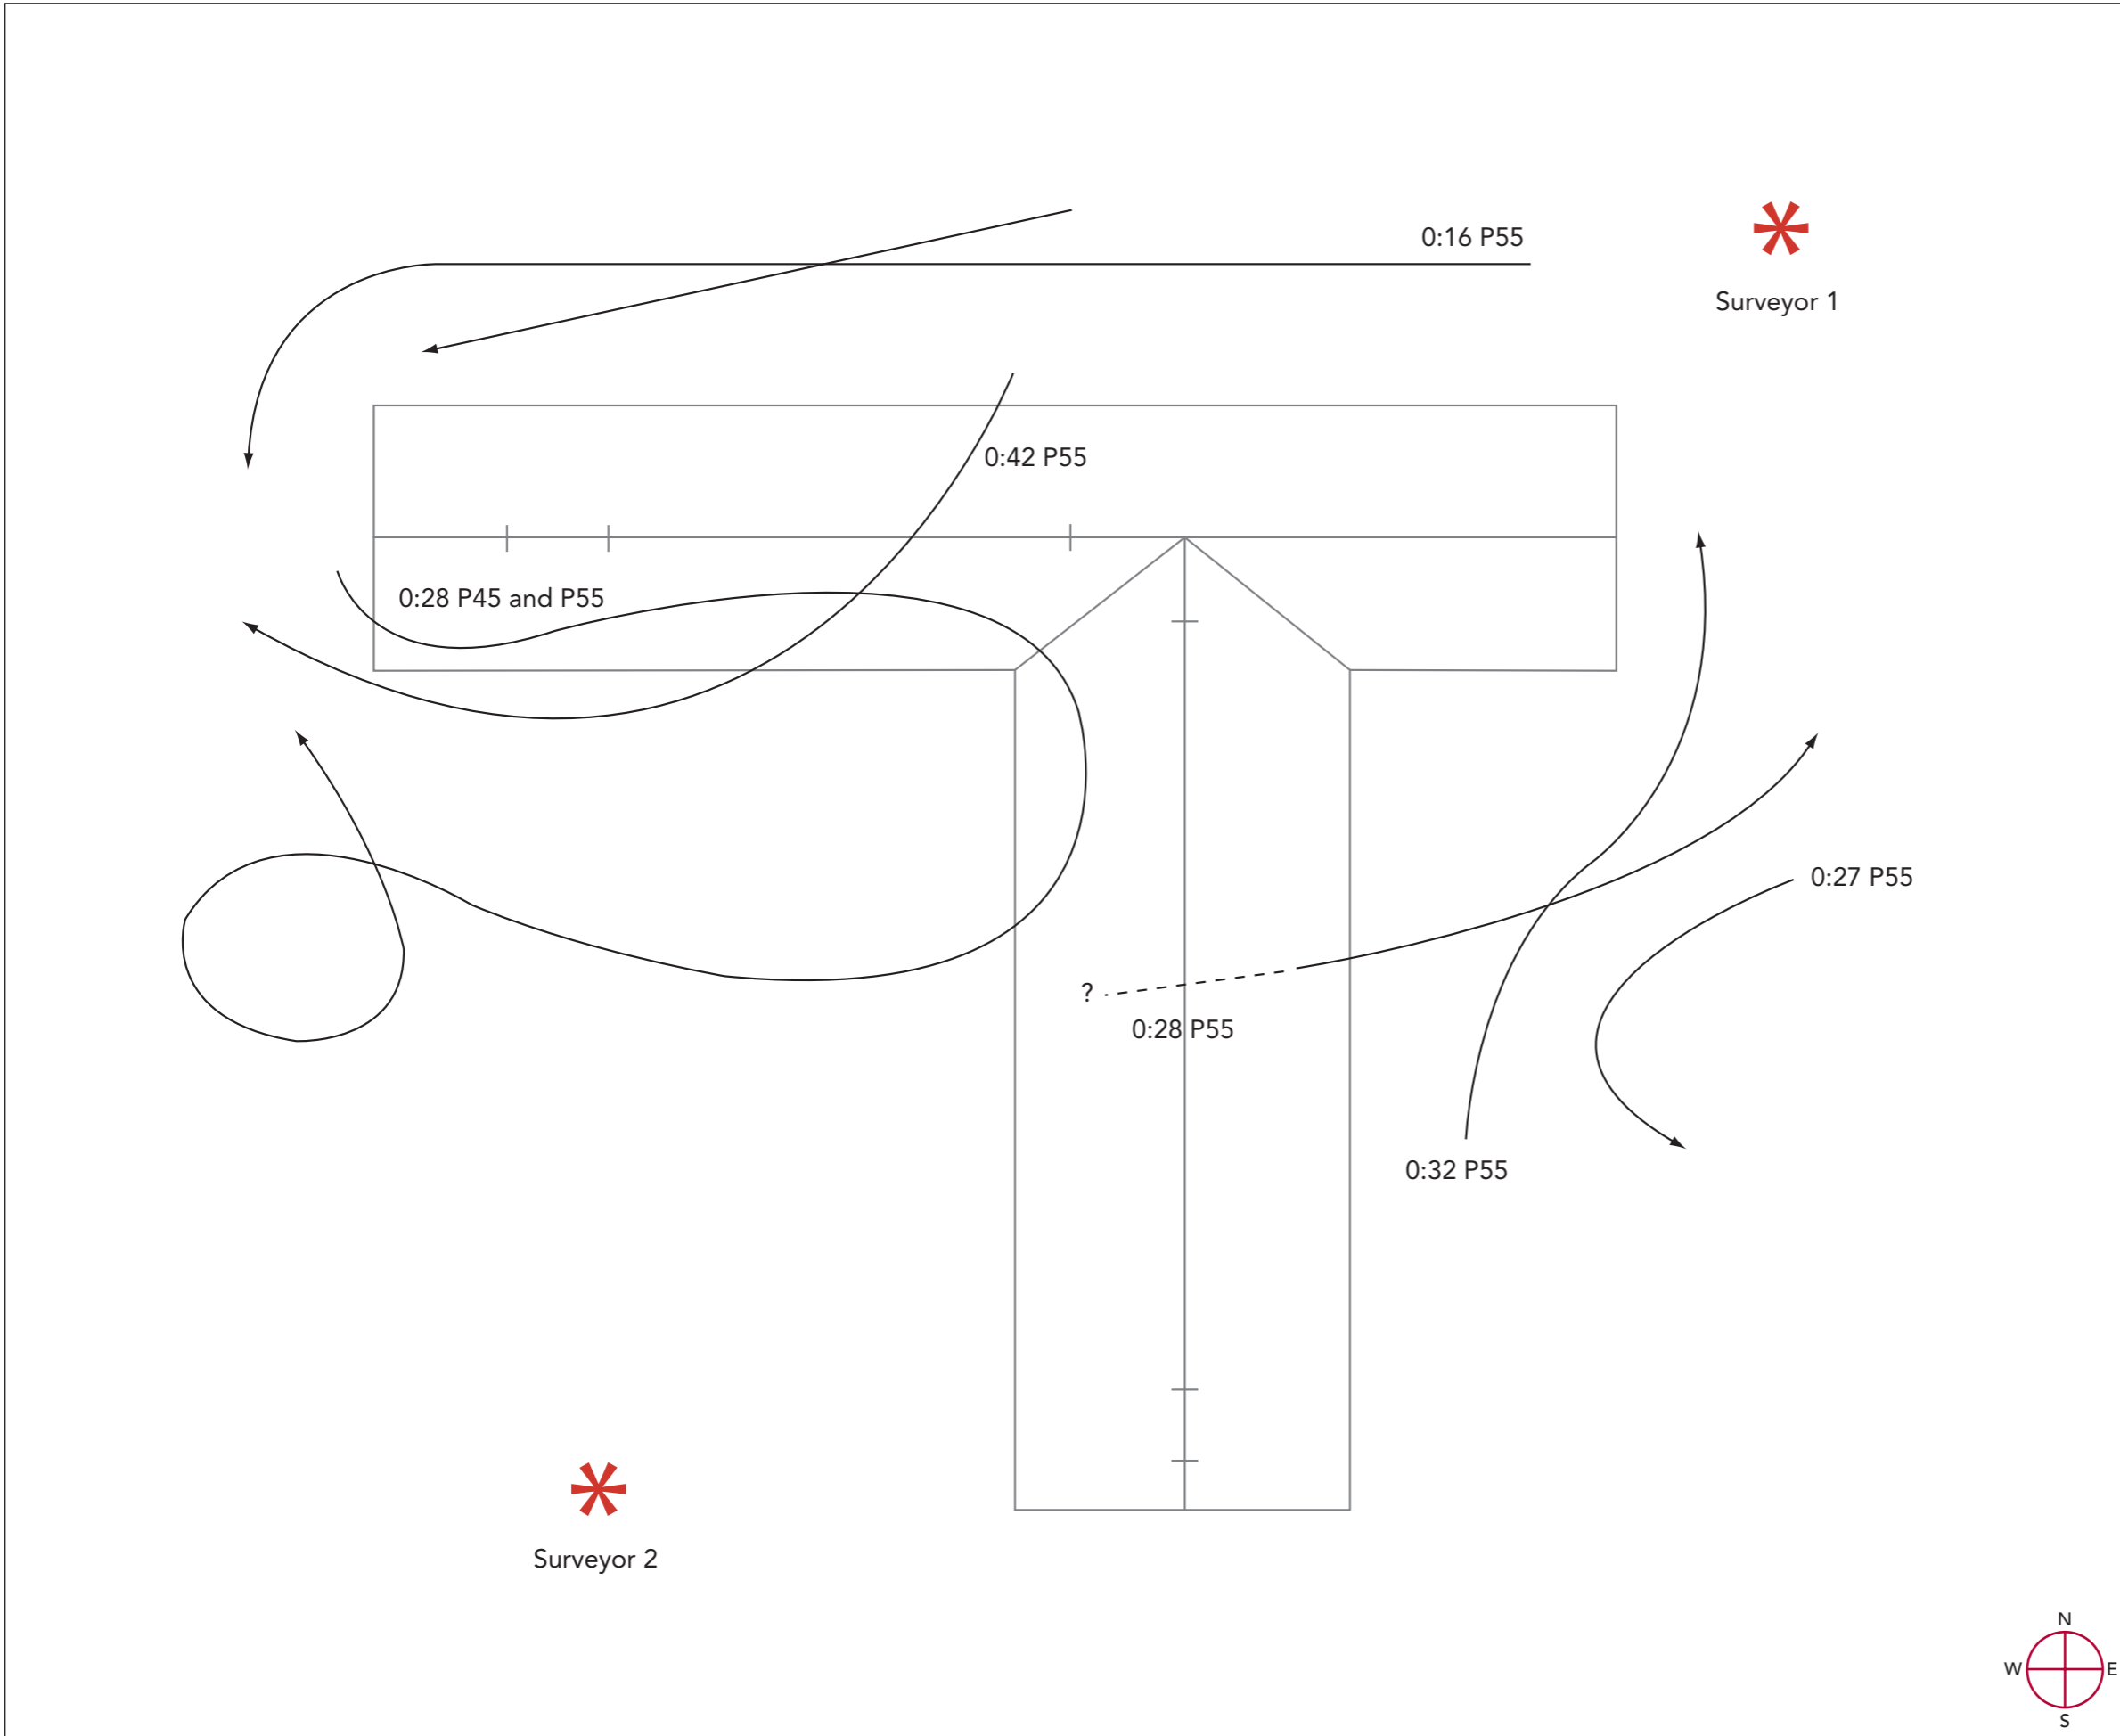
The flight lines of pipistrelle bats directly observed are shown on Figure 2. A higher level of activity was recorded from position 2 to the south-west of the pavilion with eighty-six passes compared to sixteen from position 1 to the north.

Time after sunset (e.g 0:16 = 16mins after sunset)

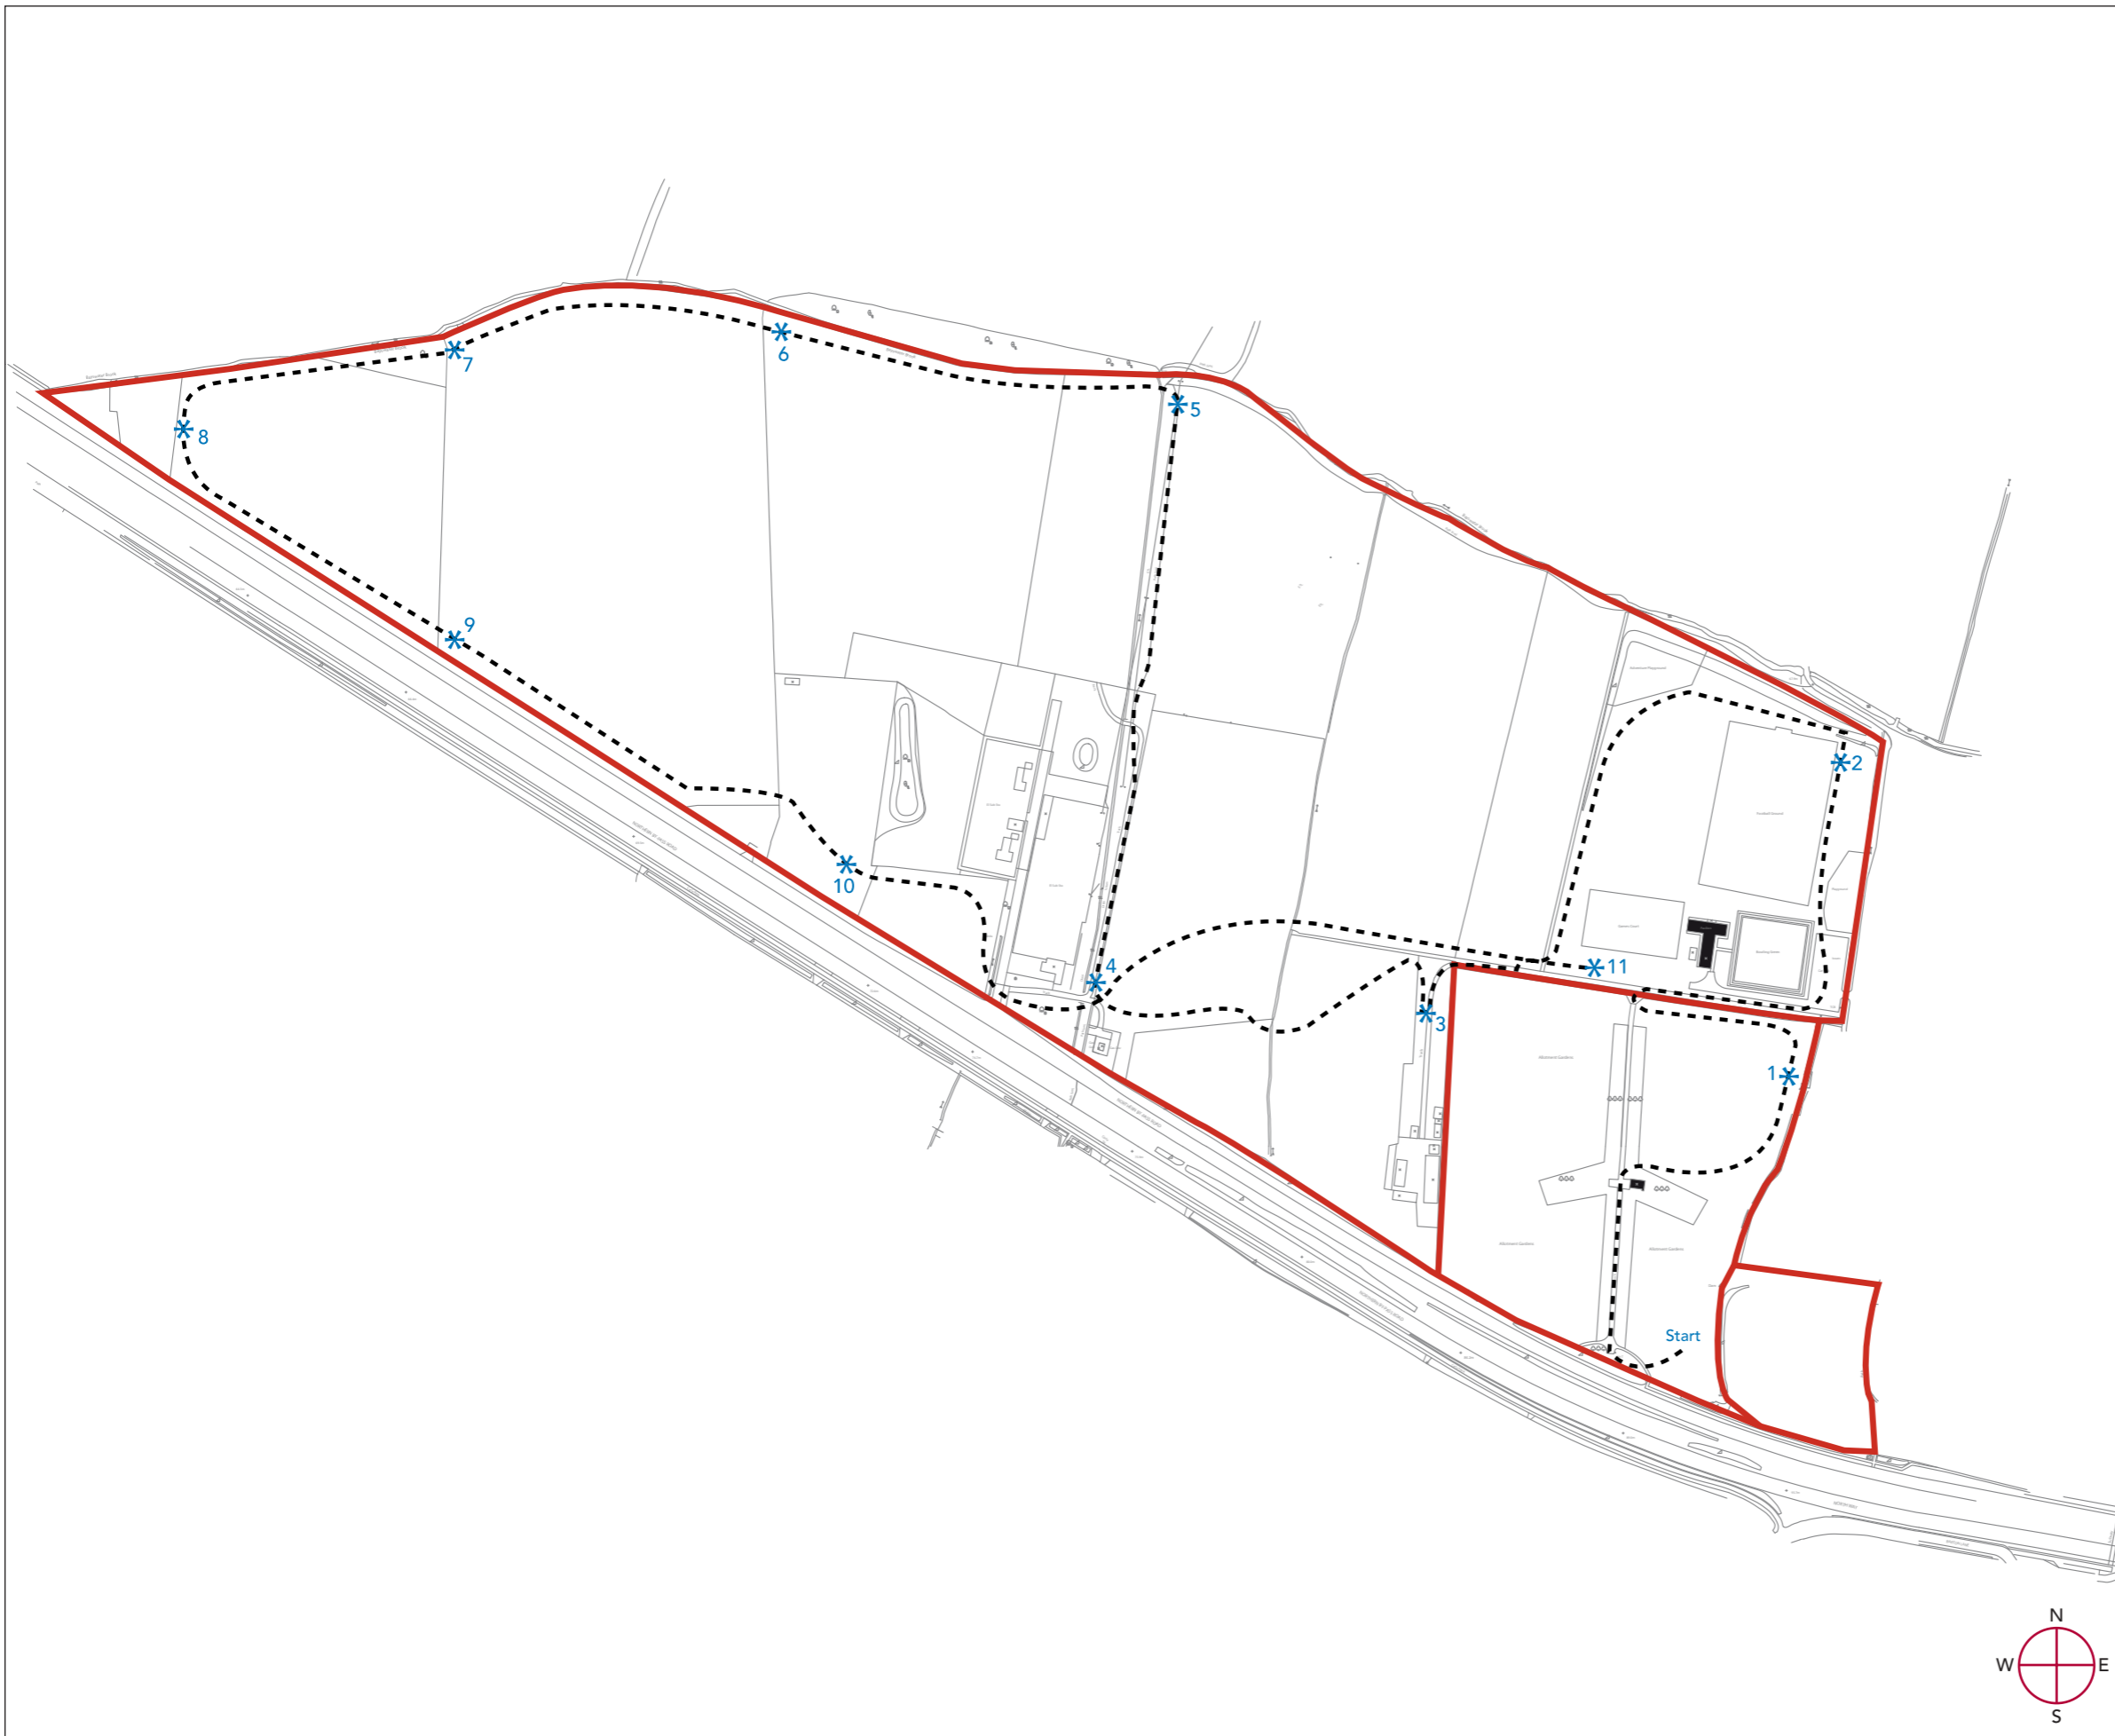
The largest number of bat passes during the survey were recorded around the northern and western edges of the playing fields (between points 2 and 3 on Figure 2) and along the hedgerow running north to south in the central part of the site (between points 4 and 5 on Figure 2). Twenty-nine and twenty-eight pipistrelle bat passes were recorded between these locations respectively. Sixteen common pipistrelle passes were also recorded along the Bayswater Brook corridor on the northern edge of the site (points 5 to 6) with a further 14 passes of this species during the stop at point 6 itself. Far fewer bat passes were recorded along the southern part of the site, with only 6 in total recorded between the far eastern end of the site (point 8) right back to the end of the transect (point 11) following the southern boundary. The patterns in bat activity are discussed further in section 4.

Transect route
