*Lye Valley  
Hydrogeological  
Impact Assessment*

## **Lye Valley SSSI – Hydrogeological Impact assessment**

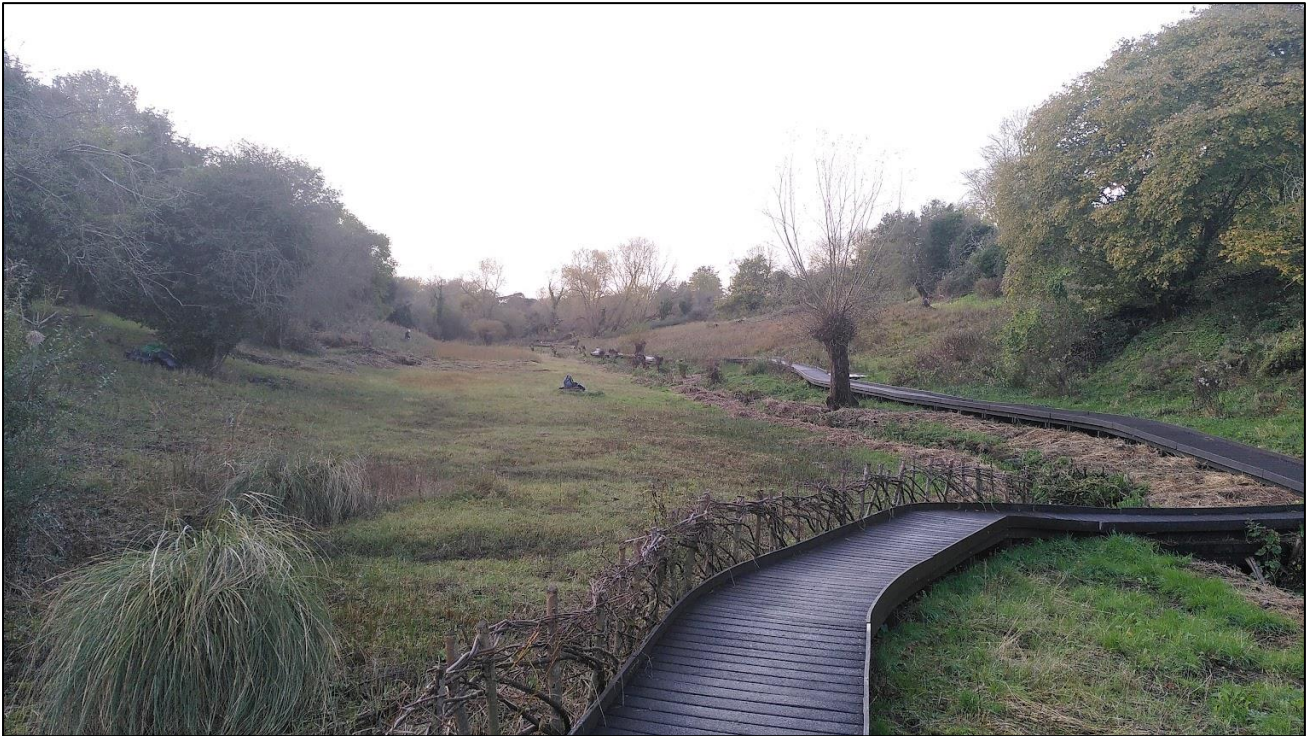
Figure 2-2: The view of North Fen looking south, with M13b vegetation forming the paler central strip at the bottom of the valley.

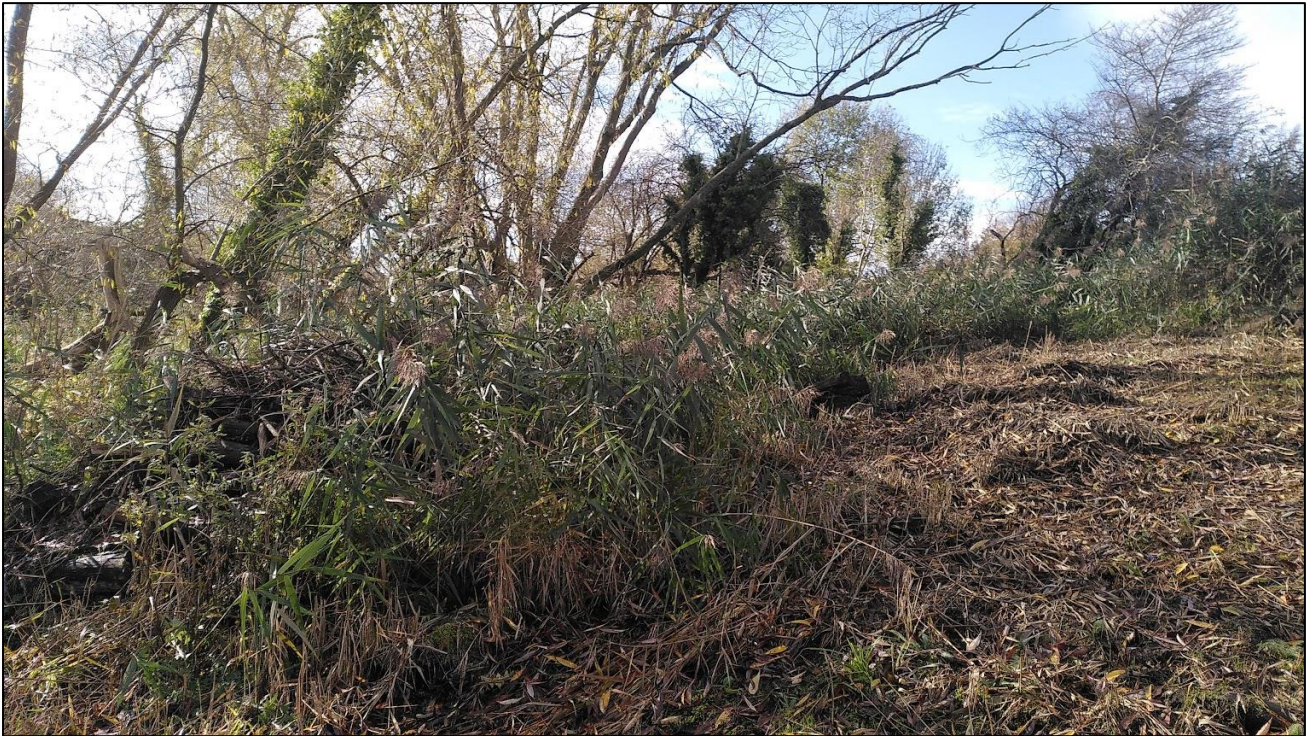
Figure 2-3: Common Reed and willows are still dominant in some areas of Lye Valley which have not been restored.

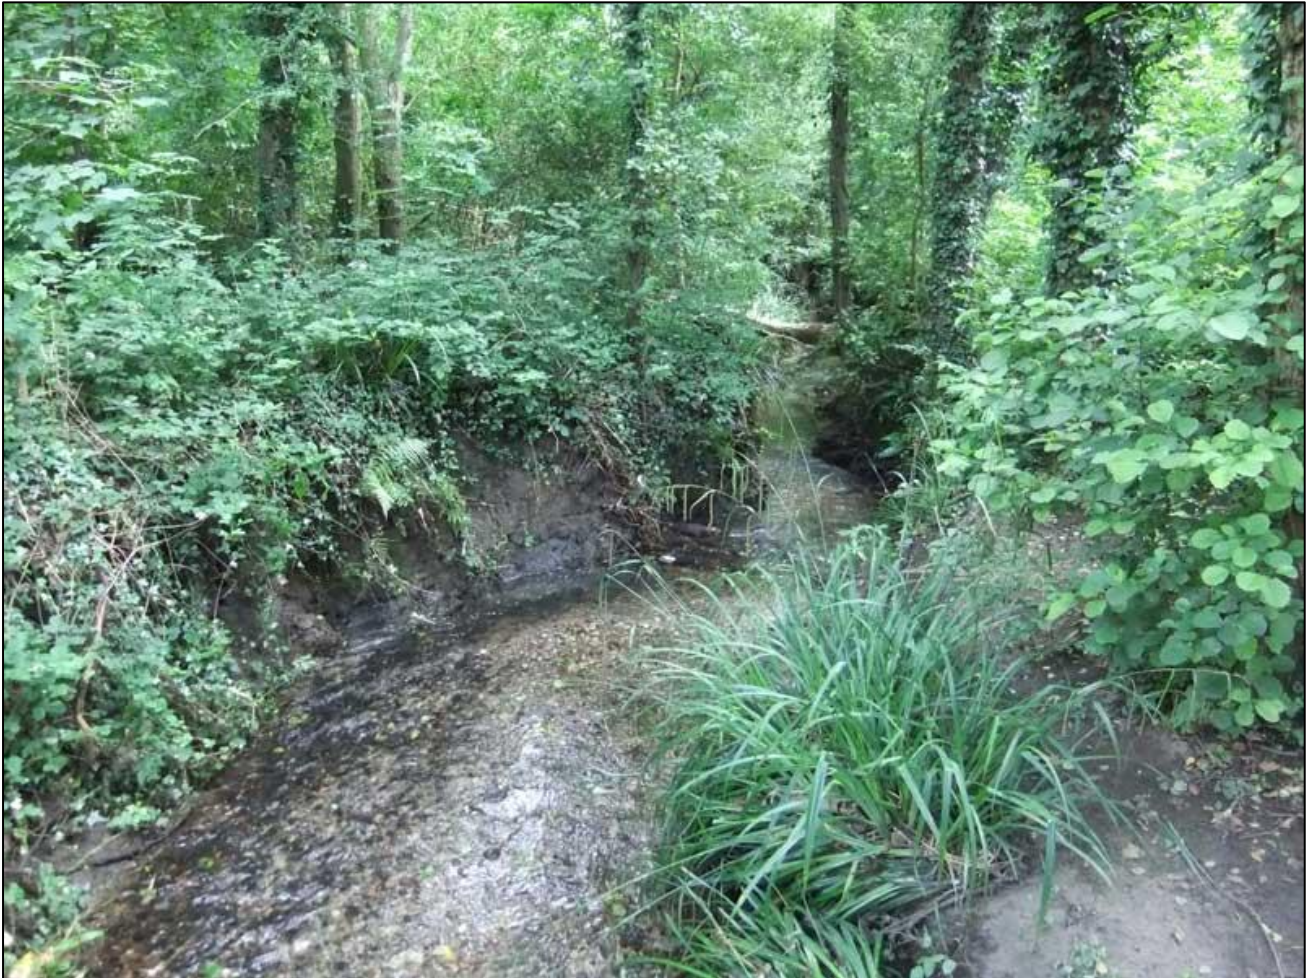
Figure 3-8: The Boundary Brook leaving the Churchill Hospital area and running down to the Lye Valley, where it is joined by the Lye Brook<sup>4</sup>.

The brook then turns south-east and runs along the edge of the golf course and then down to meet the Lye Brook in the Lye Valley Nature Reserve (see Figure 3-8). The brook then runs south-east through the golf course and then south west, emerging in Barracks Lane at the bottom of the hill. It continues all the way through the south side of Meadow Lane Nature Park and enters the River Thames approximately 2.5 km downstream of Lye Valley.

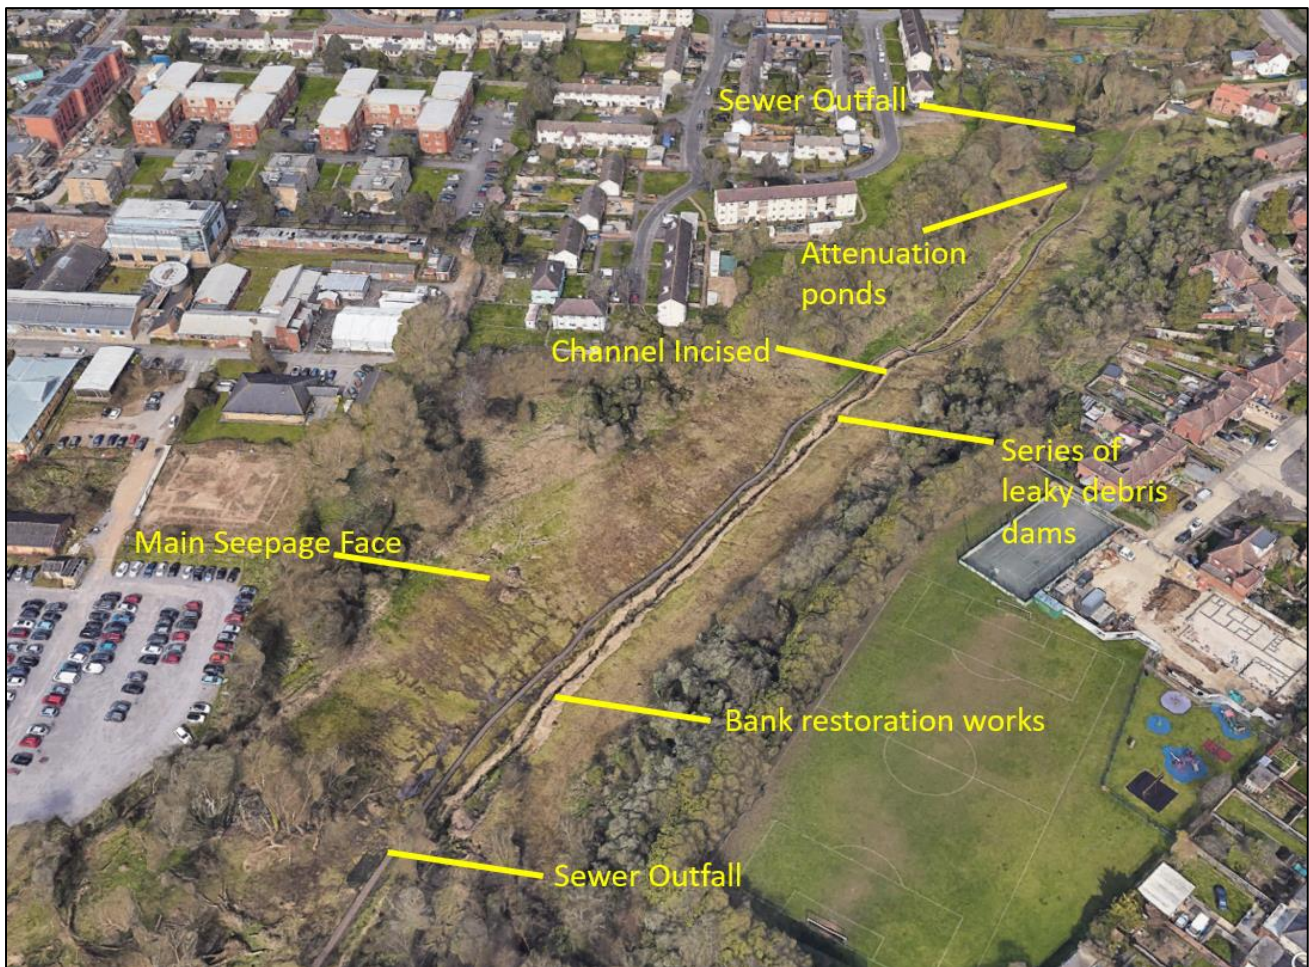
Figure 3-9: Main water features along the Lye Valley.

The Lye Brook enters the top of the Lye Valley and passes through a series of attenuation ponds. Figure 3-9 shows the main water features along the Lye Valley.

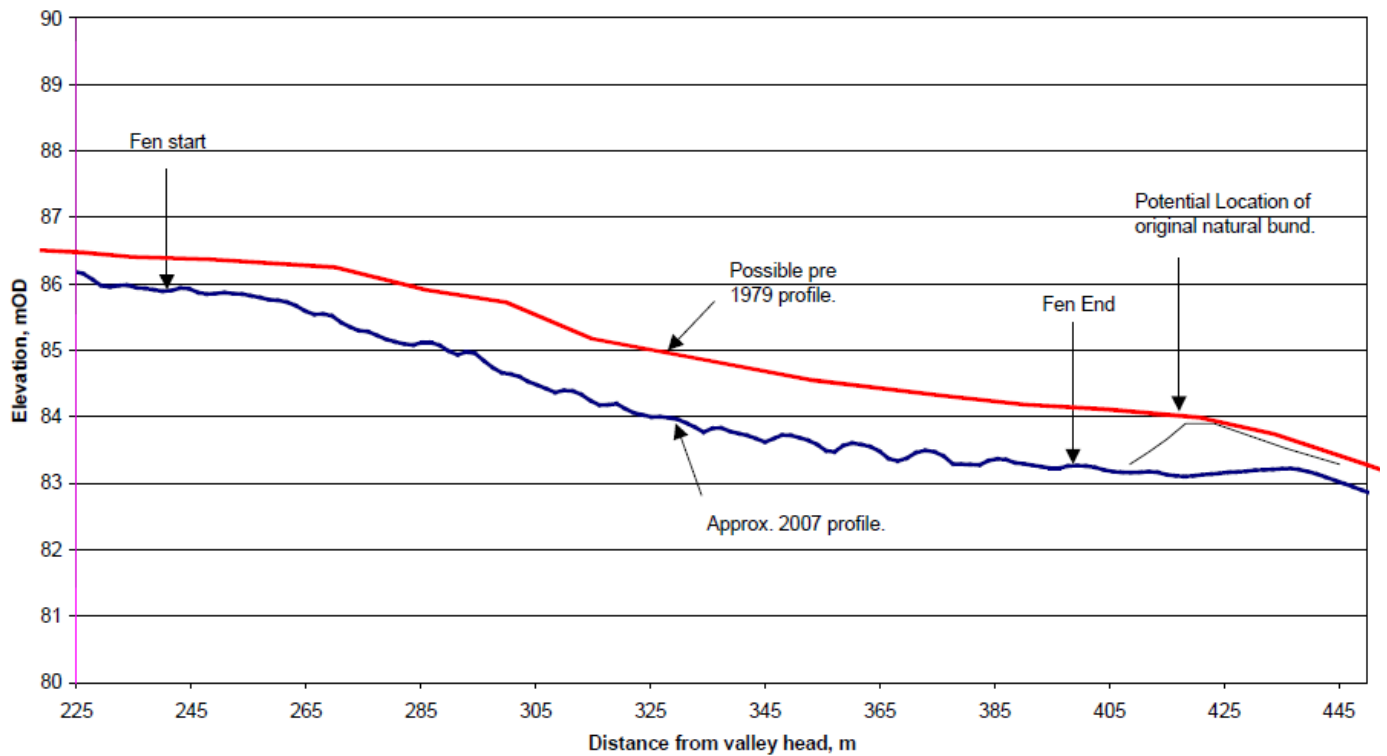
Figure 3-10: Approximate Lye Valley North SSSI stream bed (from Lambeth 2007).

The channel is incised and has cut through the soft peats and clays in the base of the valley to reach hard deposits beneath. Lambeth (2007) identifies a storm in 1979 that caused much of the incision and provides a long section of the bed profile (see Figure 3-10).

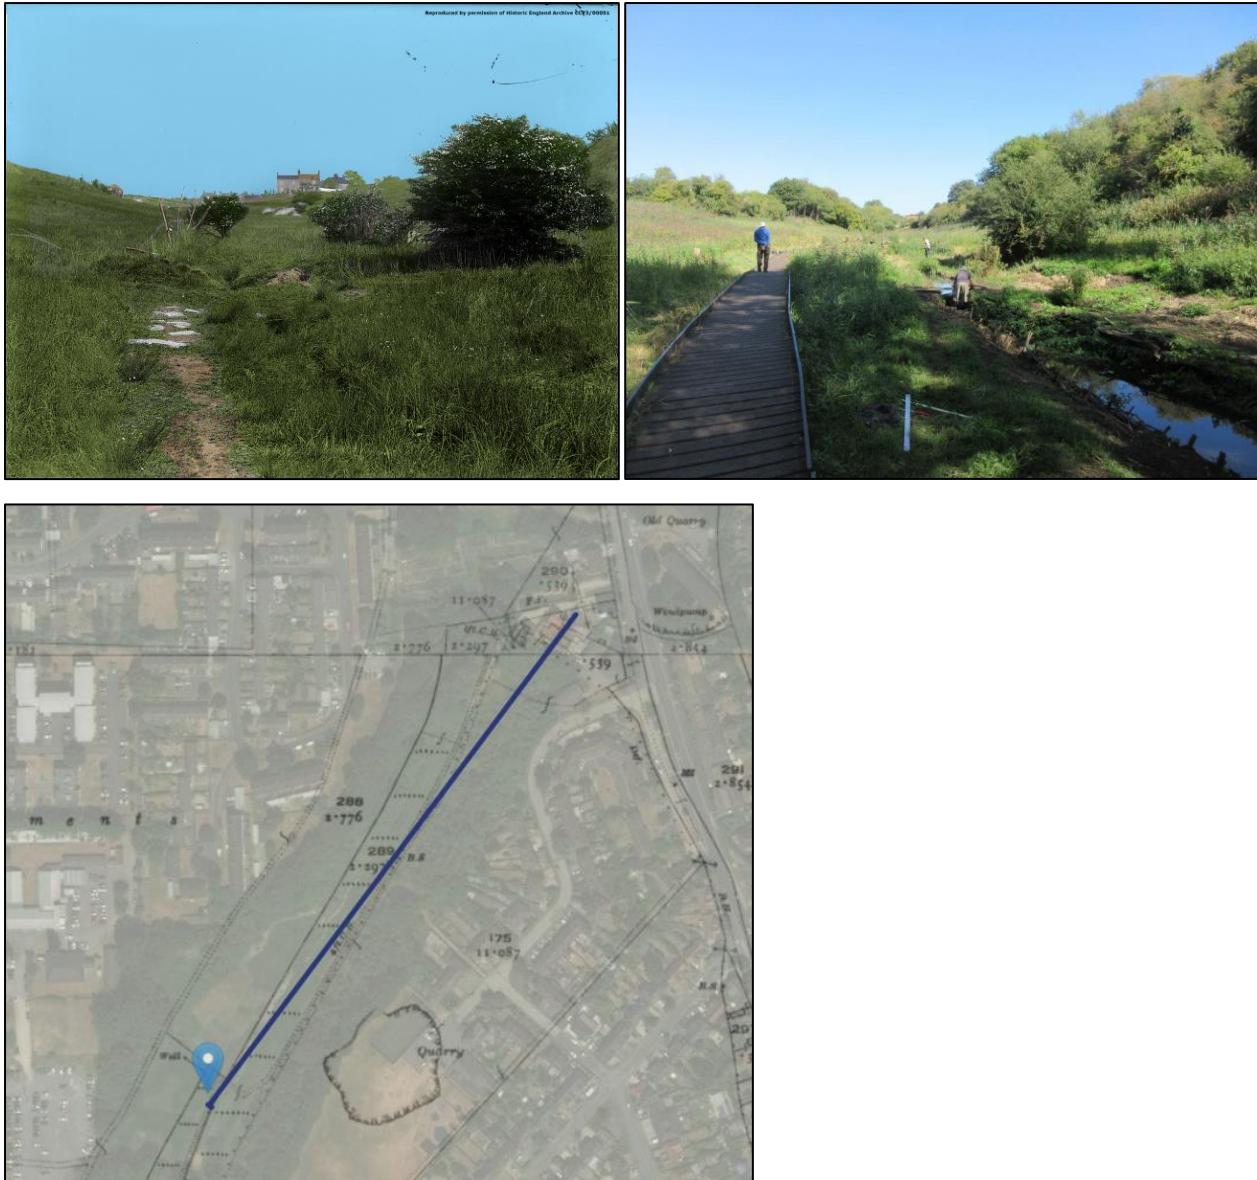
Figure 3-12: Lye Brook in 1914 and 2020 from Headington Heritage with the map showing the line of sight.

An article on the Headington Heritage website<sup>5</sup> shows the nature of the stream in 1914 compared to today (see Figure 3-12). It shows how the watercourse at that time was much smaller than today. The stream in this historic condition would have provided the low energy environment that allowed the soft peats and clays of the valley floor to be deposited.

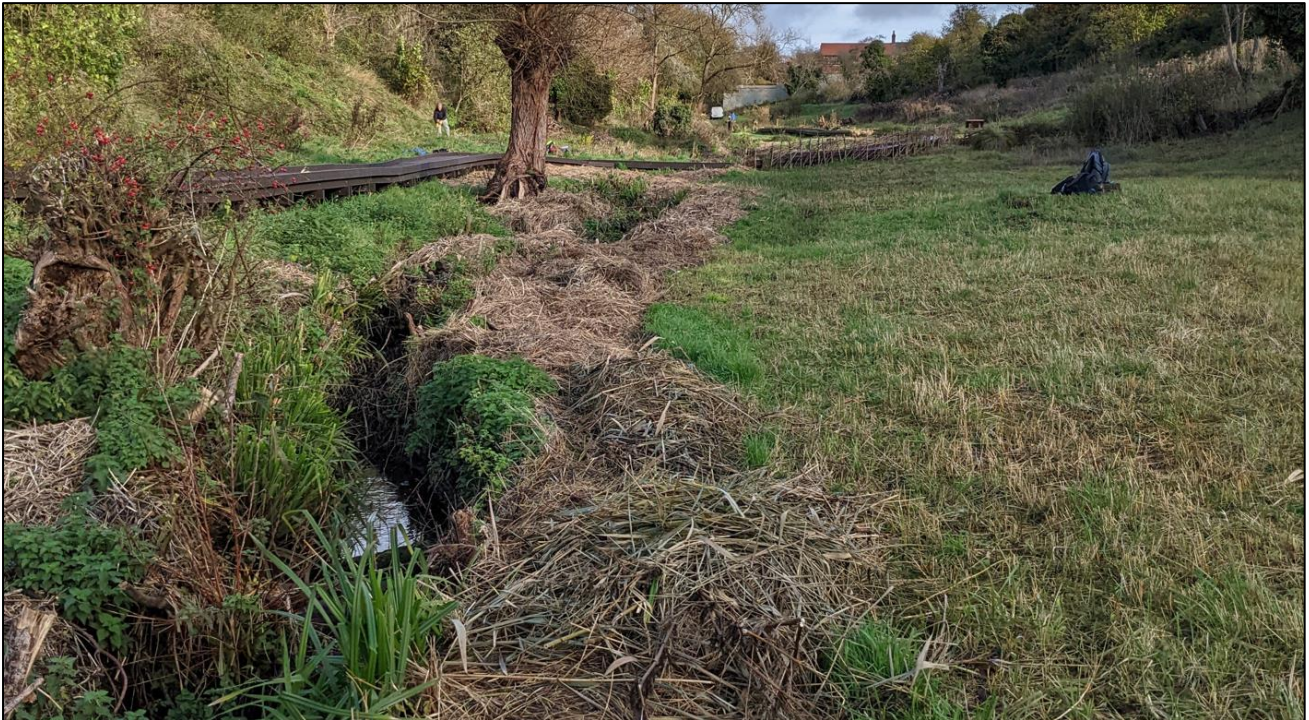
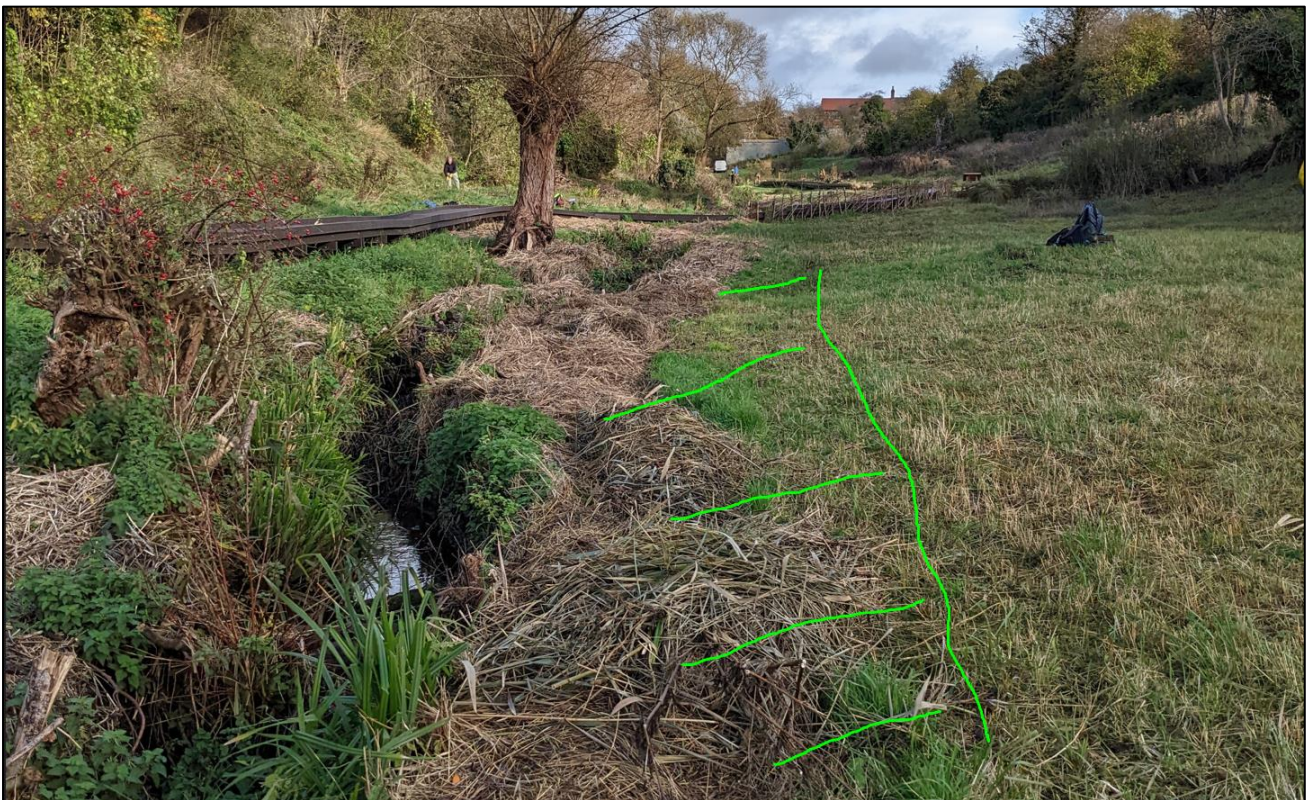
**Figure 3-13: Evidence of slumping.**

On the JBA November 2023 site visit, restoration works by the Friends of Lye Valley were observed, including repairs to the bank and leaky debris dams along the length. Slumping of the peat in the valley floor adjacent to the incised stream could also be observed (see Figure 3-13).

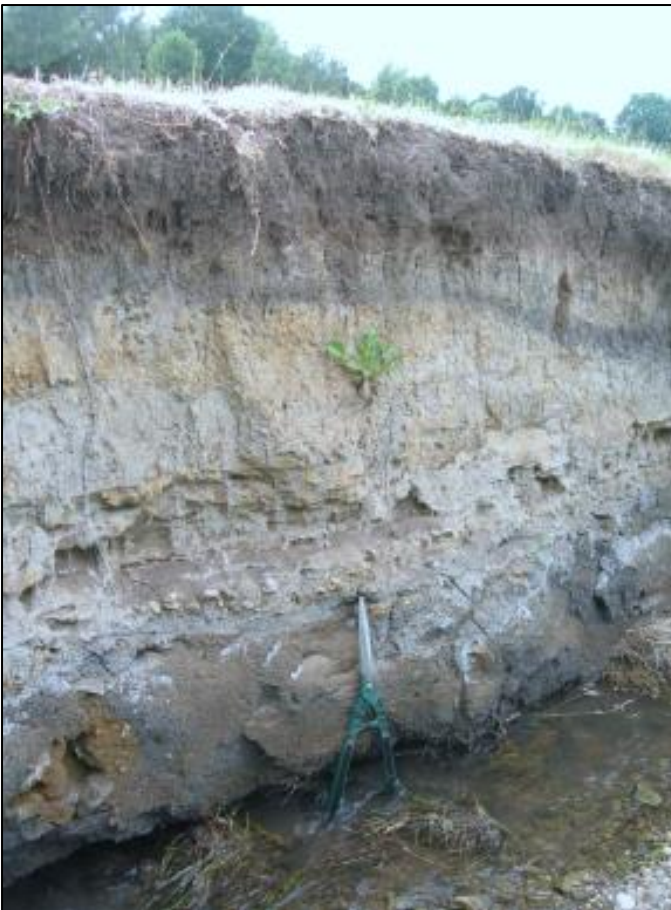
Figure 3-15: Erosion of Boundary Brook from Webb (2013).

The erosion of local watercourse also extends down Boundary Brook. Figure 3-14 shows the brook at the beginning of the 20th century, with Figure 3-15 showing erosion today. Webb (2013) estimates that the brook has incised by 1-1.78m.

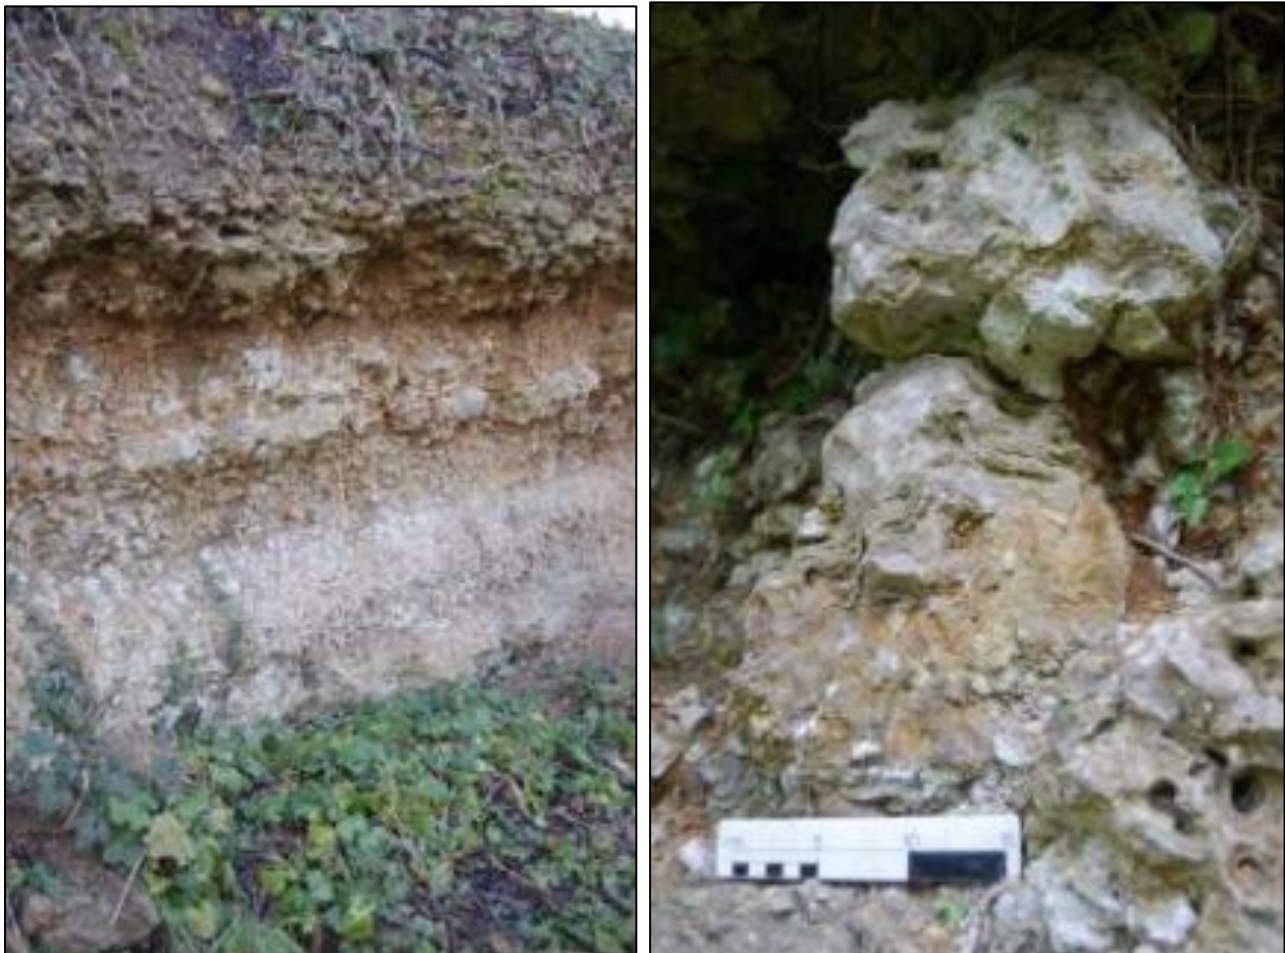
Figure 3-36: Outcrops at Crossroad Quarry.

Figure 3-36 shows the geology and rock types within the Crossroads Quarry.

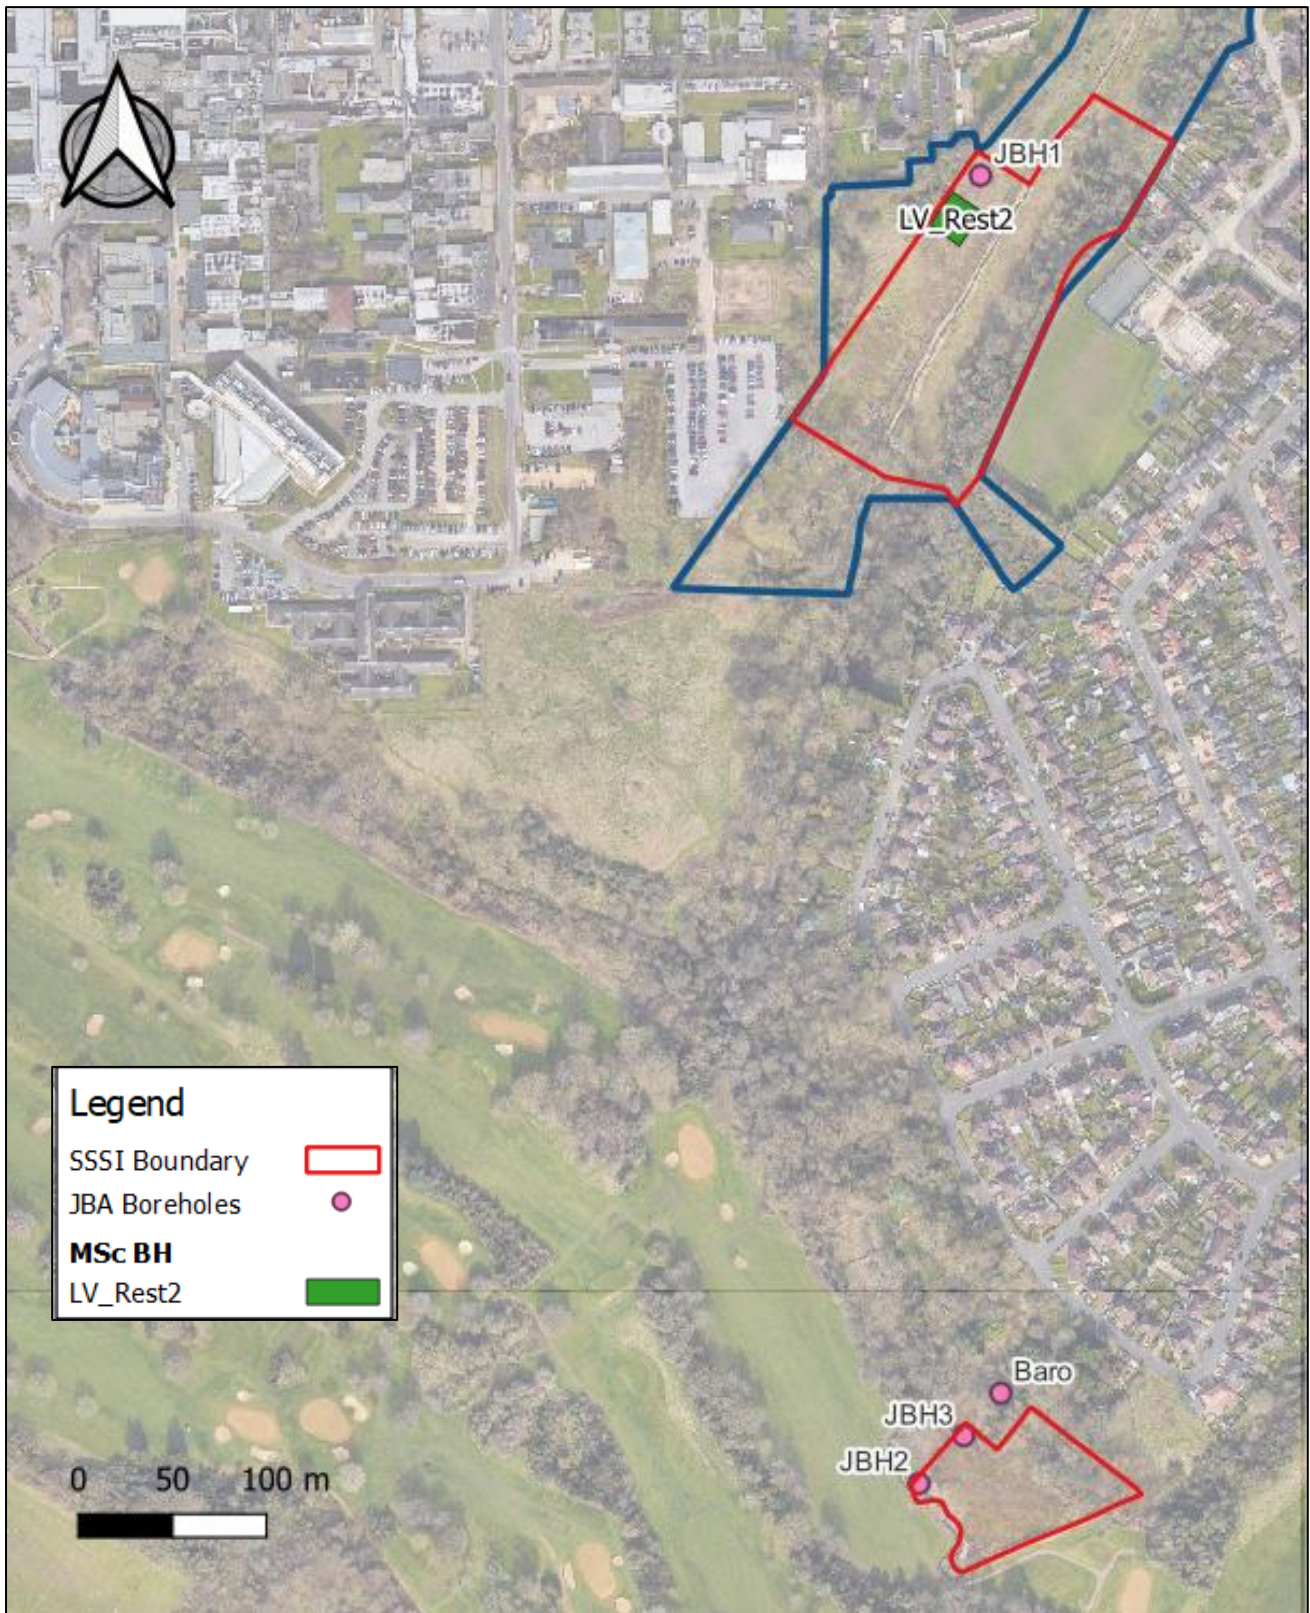
Figure 3-41: Monitoring network.

A shallow groundwater monitoring network was installed on the SSSI by JBA in February 2023 (see Appendix A). Their locations are shown in Figure 3-41, with the results shown in Figure 3-42. A simple description of the results is given in Table 3-3. Figure 3-43 shows that when groundwater monitoring started groundwater levels were at a 5 year low regionally before reaching a five year high at the end of the period, with groundwater levels peaking in the following winter after the monitoring period finished. This suggests that the monitoring period covered a good range of groundwater conditions, with the summer of 2023 representing a relatively dry period and the winter of 2023-24 a wet one.

The overall rationale for additional monitoring was to improve the understanding of the shallow groundwater conditions on site. Extensive monitoring had been conducted on Lye Valley by Adam Bows (2021). The main gap in that array was to assess the extent to which the main limestone band maintained saturated conditions up the valley side. At South Fen, no groundwater monitoring had occurred before so a transect across the wetland was installed to assess how conditions varied across the valley floor and the impact on the incised Boundary Brook on groundwater levels.

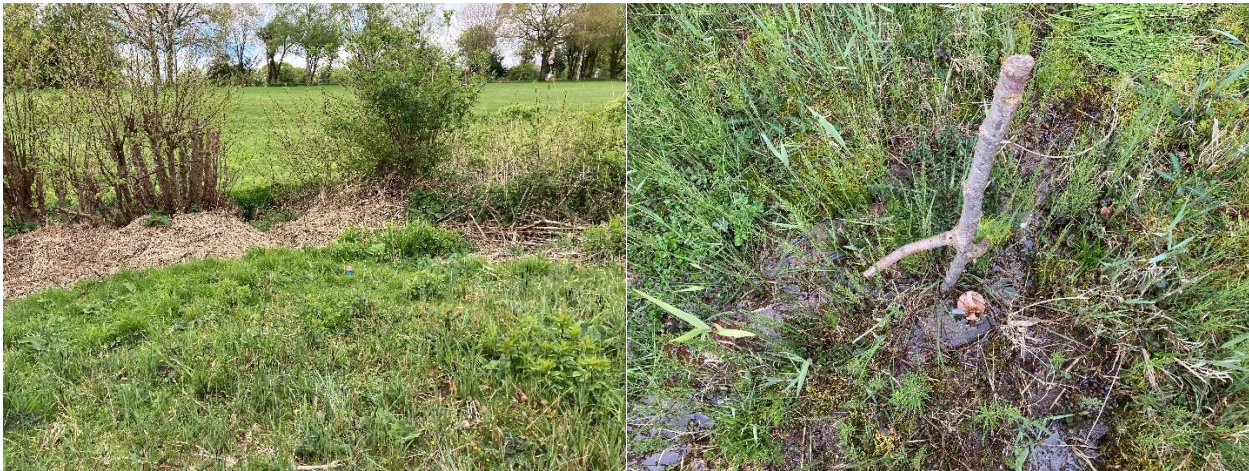
Direct water level monitoring is only one data source for water level conditions. Section 2.3.1 notes that when areas of M13 *Schoenus nigricans*-*Juncus subnodulosus* mire are drained and "water no longer oozes underfoot in a non-drought summer, can be expected to result in some loss of botanical interest". This means that the distribution of species across the site acts as a long-term record of water level conditions.

Figure 3-46: Drier vegetation around JBH2 close to the brook edge (left) compared to the calcareous fen vegetation at JBH1.

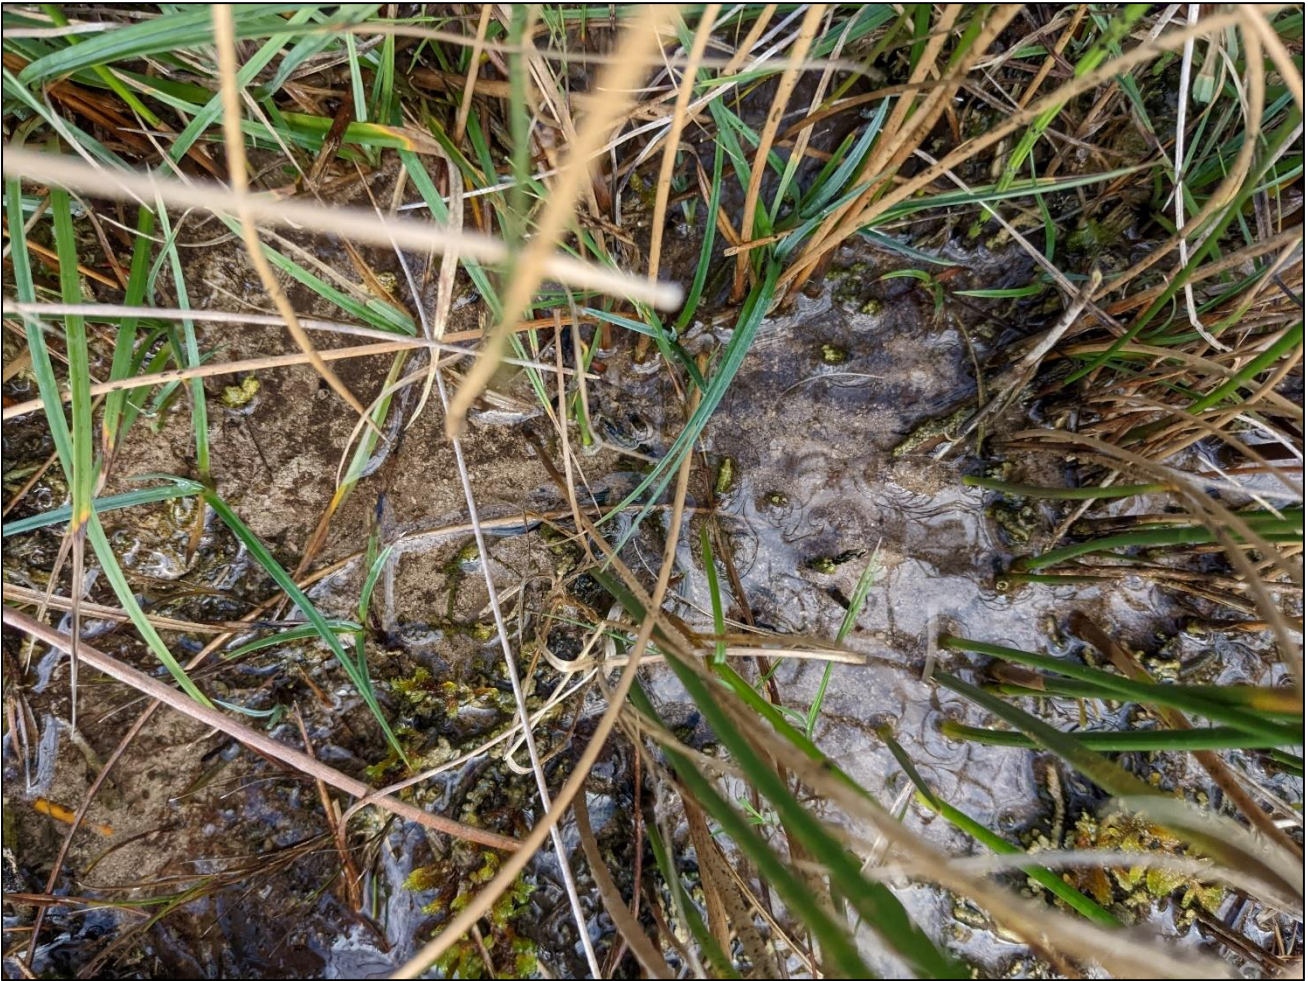
Figure 3-52: Evidence of Tufa in Lye Brook (JBA walkover).

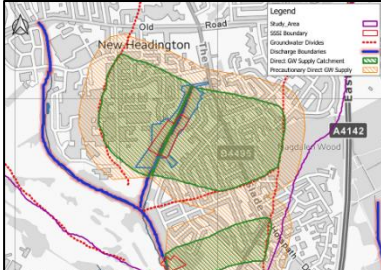
<p>Figure 5-5</p>

Figure 5-5: Zone of direct groundwater supply.

The rationale for the direct groundwater supply catchments is provided in Section 3.8.6. The section notes that there is some uncertainty around the edges of these areas due to the influence of limestone bands. Figure 5-5 includes a Precautionary Direct Groundwater Supply Catchment. This takes the originally derived groundwater catchment and adds a 100m buffer. It is tied in closer near the SSSIs, where there is more certainty about the groundwater flow paths. 100m has been chosen as it encompasses a significant proportion of the ground between the groundwater divides and the discharge boundaries.
