# The Covered Market High Street Oxford

## HERITAGE ASSESSMENT

June 2013

Oxford City Council

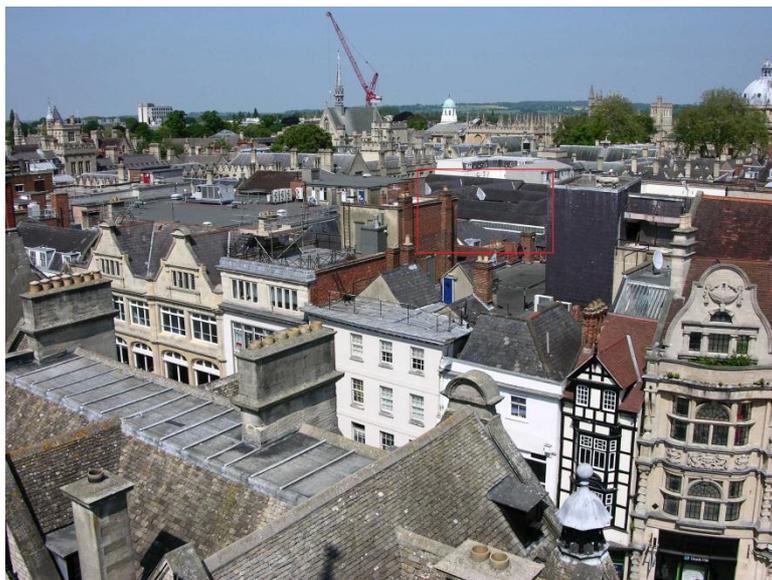
From high viewing points, mainly Carfax Tower the roofs of the Market can be seen and its location within the city block understood.

**Fig 2: Views of the roofs of the Covered Market from the top of Carfax Tower looking NE.**

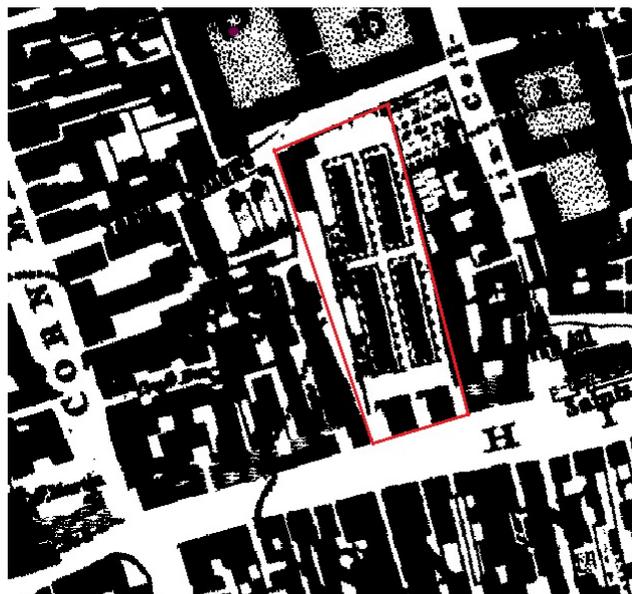
Fig 4: Faden Map of Oxford 1789 showing construction of Covered Market and Market Inspectors House to the west.

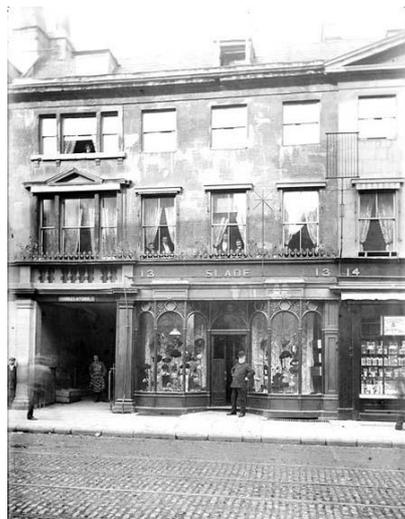
Fig 5: This image Nos 13-14 High Street, designed by Gwynn was taken by Henry Taunt in 1905. One of the four covered walkways into the Market from the High Street is also visible to the left of No 13.

Properties on the High Street frontage (Nos 12-16), above the avenue entrances, a part of Gwynn's 1774 design were sold to raise money for the construction.

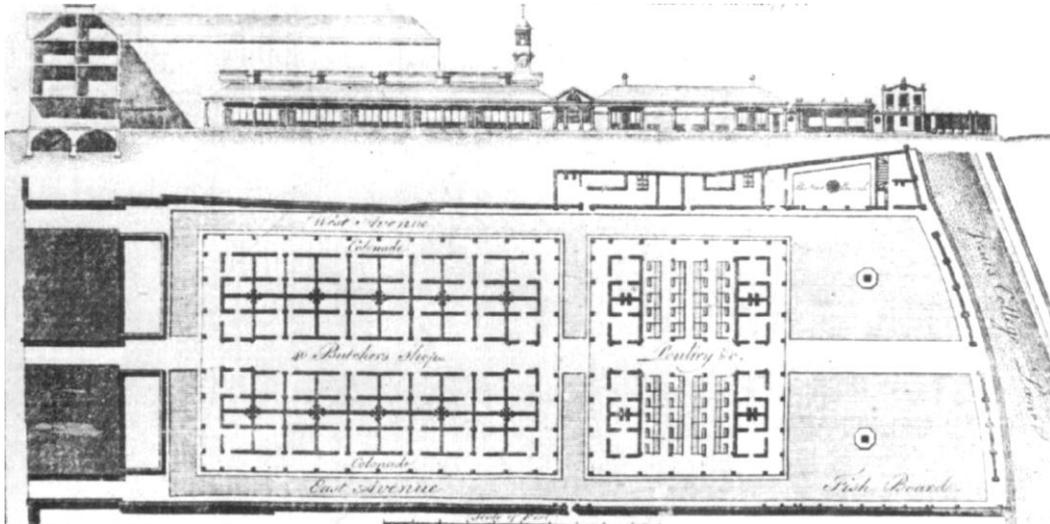
Fig 6: John Gwynn's plan and elevation of the Market 1774. Malcolm Graham, 'The Building of Oxford Covered Market, Oxoniensia, XLIV, 1979, p91.

By 1775, there were 28 shops and 40 butcher's shops which were divided into blocks by wide avenues. The shops were constructed on stone foundations and were timber-framed with lath and plaster walls with Stonesfield slate roofs and surrounding stone colonnades. At the north end of the Market there was an open area for fisherman, gardeners and other goods. There were three entrances to the Market along Jesus College Lane (Market Street). In 1789 a house was constructed for the Market Inspector in the NW corner of the site.

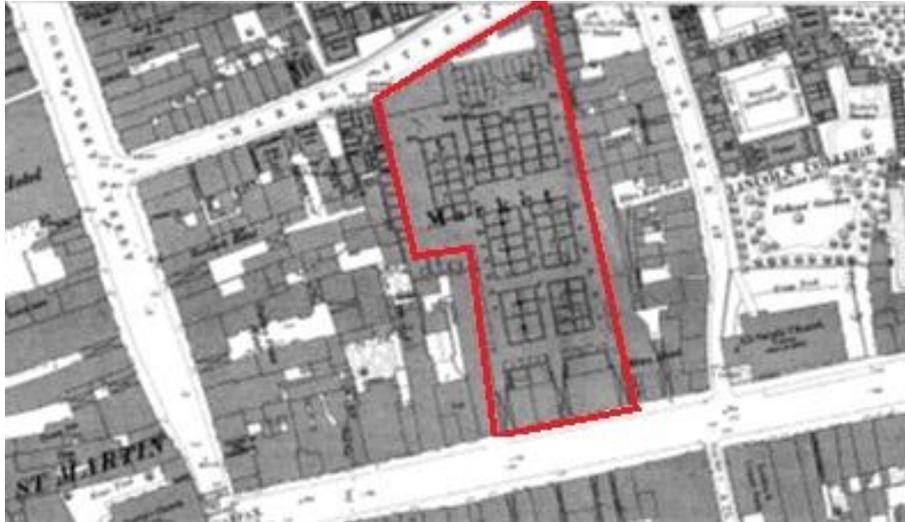
Fig 7: 1<sup>st</sup> edition Ordnance survey map for Oxford 1872. Oxfordshire County Council.

The 1st edition of the Ordnance Map for Oxford dated 1872 shows only three avenues into the Market from High Street and open stalls at the north end of the Market fronting Market Street.

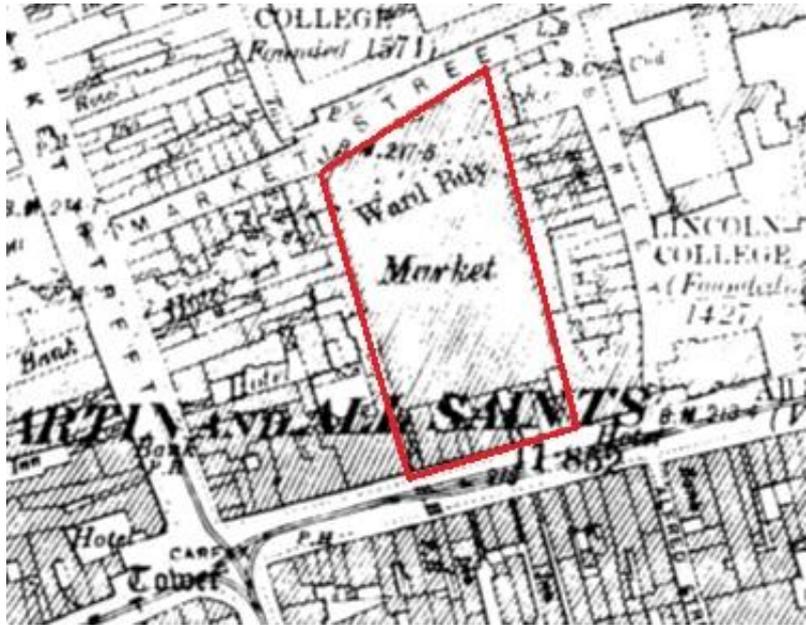
Fig 8: 2<sup>nd</sup> edition Ordnance Survey Map for Oxford 1898-1900.

The 2<sup>nd</sup> edition Ordnance Survey Map for Oxford shows the new 4<sup>th</sup> Avenue entrance off the High Street. It also shows that the open areas to the north and east of the site had been covered over by 1900.

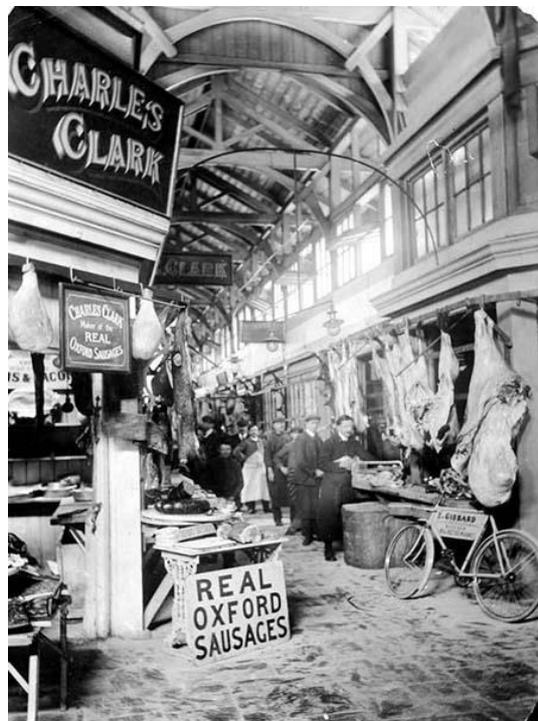
Fig 9: Photograph of the interior of the Covered Market. Henry Taunt 1909. Oxfordshire Local Studies Centre. HT11025.

The photograph above taken in 1909 shows several butcher shops advertising their goods in the foreground. There is also sawdust covering the floor.

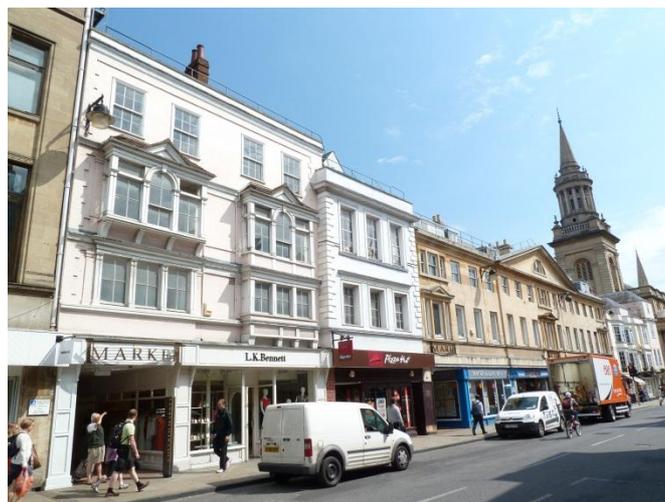
The Market fronts on to both Market Street and the High Street. The High Street elevation, which is three storeys, is composed of a formal classical C18th façade with wide central pediment, sash windows on both first and second floor – the first floor windows being taller, and with three, pedimented tripartite sashes spaced at regular intervals along the façade. The High Street façade (which has retail uses on the ground floor with the first floors in separate occupation and ownership) is part of a street that exhibits considerable variety in architectural form.

Fig 11: View of High Street elevation.

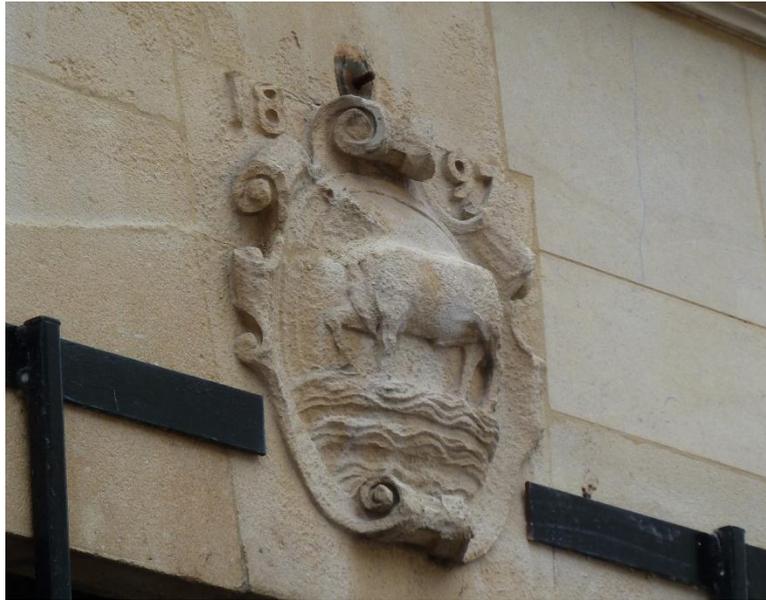
**Fig 12: Image of cartouche fronting Market Street**

Market Street has a different character and a sense of being a medieval lane. This elevation of the market is more varied, in part a limestone ashlar façade with blind arcading and an off centre main entrance and further along the white timber framed skeletal structure that supports the extended roof of the market. The stone facade has three gabled bays to the right with ball finials. On the ground there is a blind arcade which is purely decorative with imposts which the arch springs from and keystones above the gateway on the left and centre. Above the gated entrances on the first floor are Venetian windows with 6 lights. The end bay on the right has a pilastered carriageway entrance with a small cartouche above depicting the City's coat of arms and date of 1897.

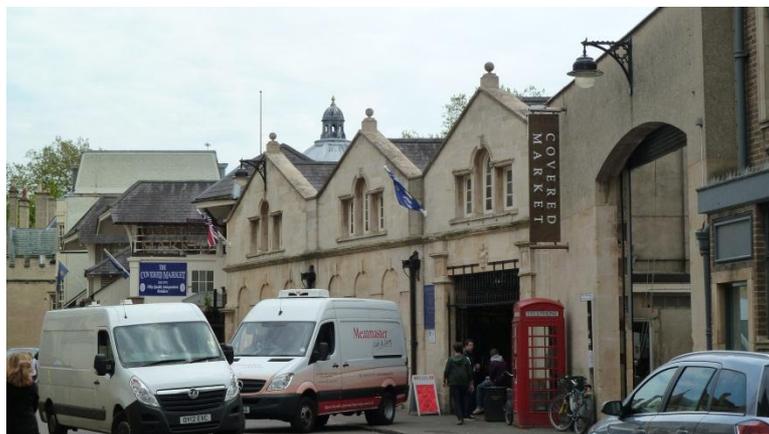
On the left the timber roof is hipped with cantilever brackets built in to support the roof canopies, which projects out over glazed timber and open ends to aisles. At the eastern end there is a large timber louvered hipped roof ventilator. The 4 metal entrance gates are probably 19<sup>th</sup> century with decorative arrowhead tops.

**Fig 13: View of the Market Street elevation**

In between is a more recent, flat roofed public toilet block, which fortunately is mostly obscured in long views up and down the street.

The stone façade has been repaired and redecorated recently and new signage fixed to the Market Street elevation.

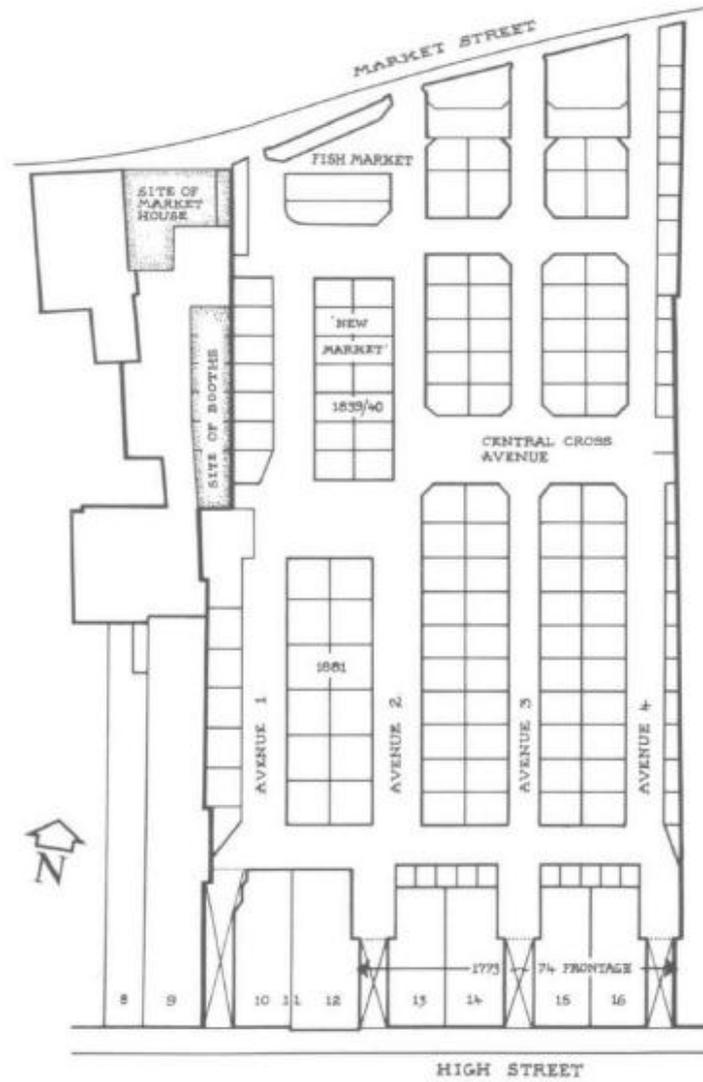
The structure is comprised of several phases of building and reconstruction from the 19<sup>th</sup> century onwards. This plan of the Covered Market from 1979 shows how the Market has evolved from the 19<sup>th</sup> century.

Fig 14: Plan of Interior of Covered Market dated 1979. Taken from Malcolm Graham, 'The Building of Oxford Covered Market, Oxoniensia, XLIV, 1979, p83.

As shown on plan the earliest surviving roof structure is in the north west corner of the Market. Also known as the 'New Market', unlike the rest of the Market the roof here is constructed of cast iron and is made up of a series of trusses and tie beams held together with tie rods set on pyramidal capped brick rendered columns.

The back to back stalls, dated 1881 on the above 1979 plan, are contemporary with the 1881 roof. Although many of the 19<sup>th</sup> century shopfronts have been replaced many achieve good proportions in shop front design, with components such as cornice, fascia board, division of window glass and stallriser well related to each other. Elsewhere some of the shop fronts have been replaced and have been built outwards below the fascia into the aisles. This encroachment of shopfronts, including the windows, obscure views of the traditional shop front designs and impede views along the avenues.

The northern half of Avenue 2, 3 and the majority of Avenue 4 shown on the 1979 plan above were rebuilt in the in the late 1880s. The timber roof has King-post trusses with braces and struts with internal glazed gallery above the shopfronts and open clerestory above.

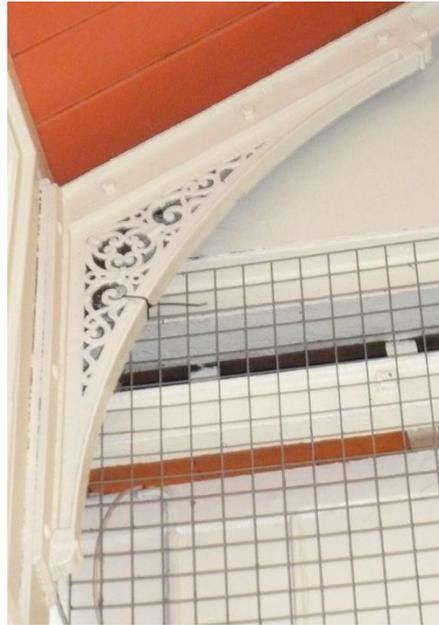
**Fig 15: View of cast iron roof in the Covered Market.**

The cast iron roof projects over the northern end of avenues 1 & 2 with a pitched slate roof tiles. There is a large metal glazed lantern with a pitched slate roof above the western side of the Central Avenue. The Central Avenue runs west/east and steps northward's along avenue 2. At the north gable end of the roof are decorative spandrels with foliage motif.

The ironwork has been painted white to reflect the light. Visible on one of the tie beams is an inscription for 'Dewer London 1839'. Little is known of the work of the Dewer Foundry in London, although they did cast iron Dragons, designed by London Architect, J. B. Bunning, that marked the boundaries of the City of London.

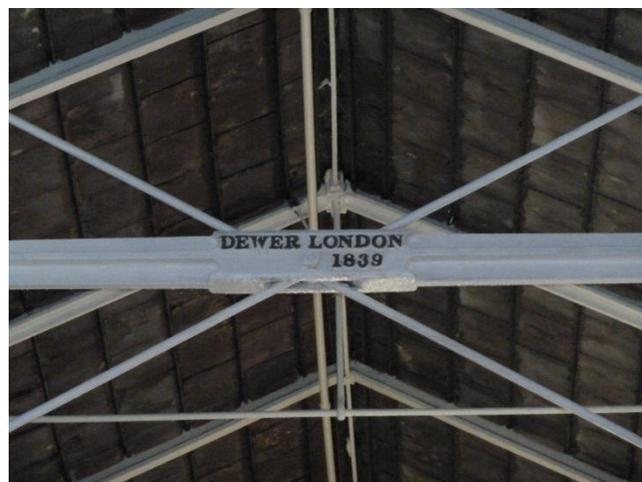
**Fig 16: Image of inscription above avenue 1.**

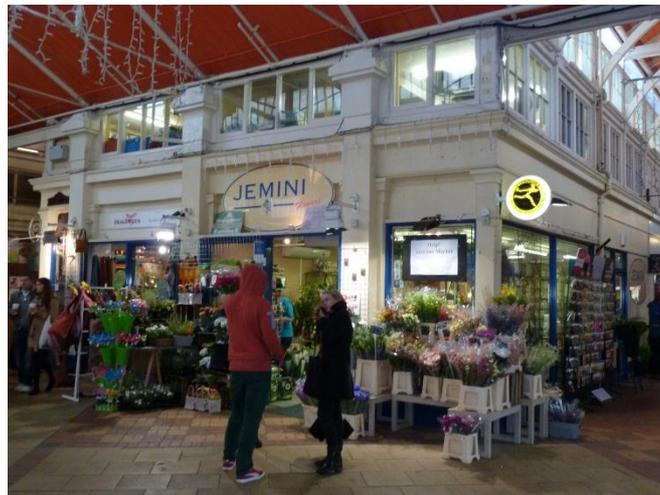
On the south side of the Central Avenue part of the 1830s shopfront has survived complete with moulded cornice, fascia board and pilasters.

**Fig 17: View of late 1830s shopfront at west end of Central Avenue.**

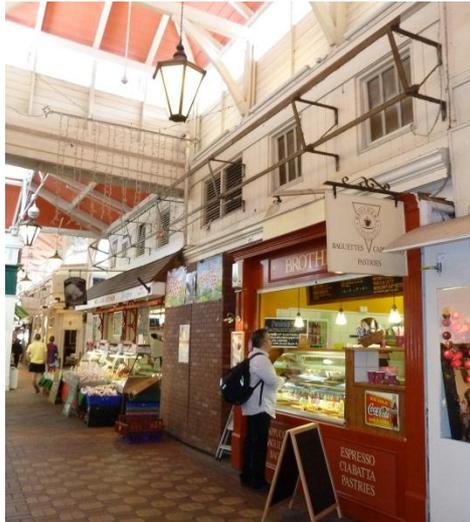
Above the shopfront at the northern end of avenue 2 facing east the 19<sup>th</sup> century iron bars remain above the cornice. These projecting metal bars were used to hang the meat on the outside of the shop.

**Fig 18: View of metal bars above the shopfront of Nos 61-64.**

Further examples of these projecting metal bars can be found above shopfronts along Avenue 2 and 3 and in the Central Avenue and continue to operate as butchers shops. In some instances the ironwork has been used to fix new sign boards and external lighting, which in some instance is clumsy and conceal views of glazed gallery and timberwork above. A number of air conditioning units have also been fixed behind ironwork or above the fascia board which obscures views of the roof construction.

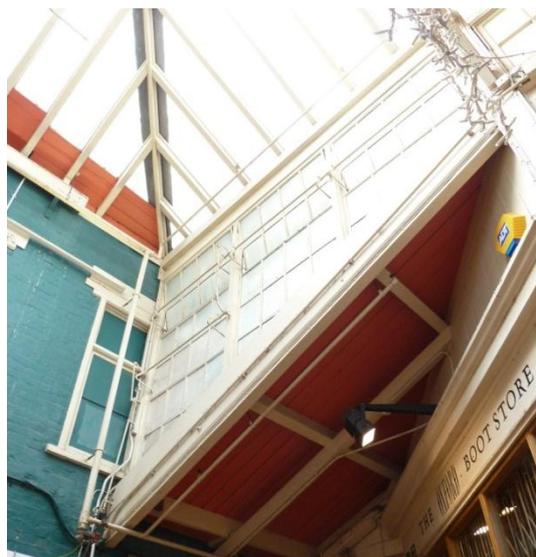
**Fig 19: View of concealed window above south entrance in avenue 1.**

The glazed timber roof above partially conceals the earlier 18<sup>th</sup> century 3 light mullioned and transom casement window at the rear of No 10 High Street.

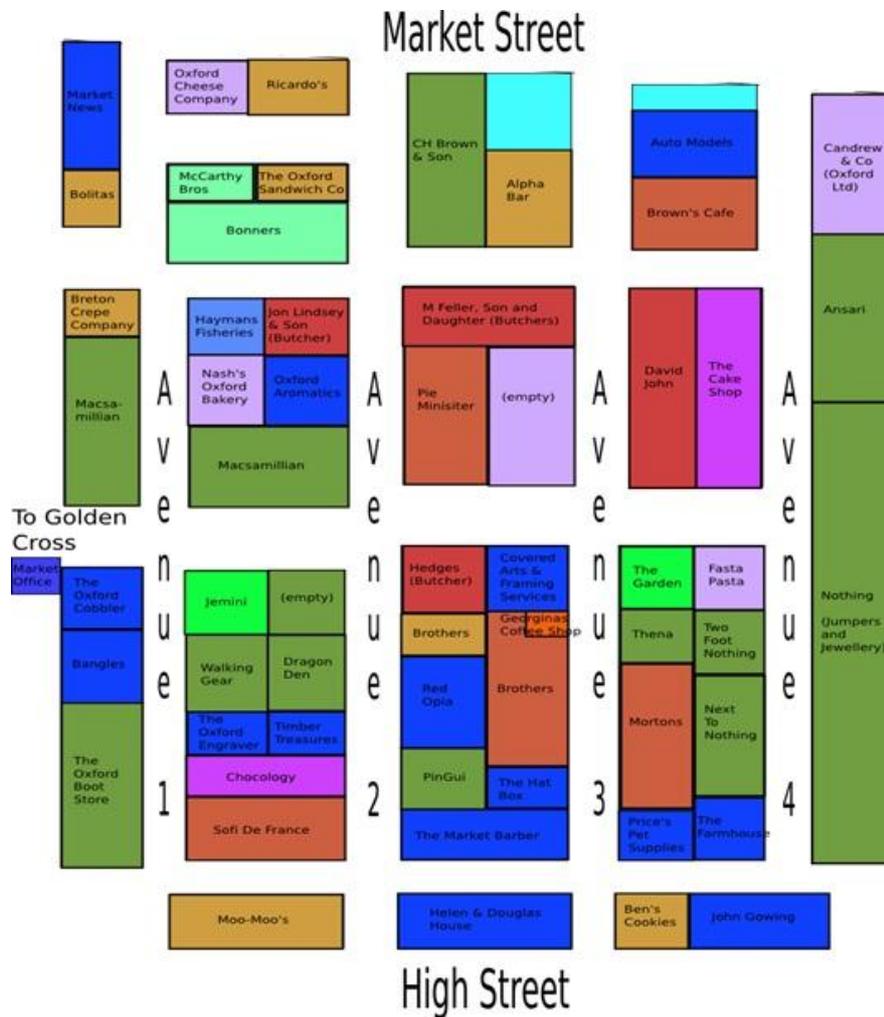
Fig 20: Plan of Covered Market dated 2011. [www.gagruarr.org/misc](http://www.gagruarr.org/misc)

This more up to date plan of the interior of the Market shows how many of the back to back units have been merged to form larger units.

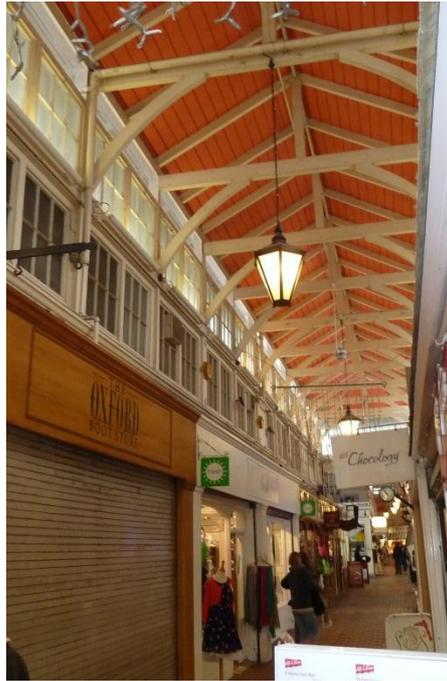
The roof construction along avenues 1 & 2, including the cross aisle at the southern end of the Market is timber framed with King-post roof trusses.

**Fig 21: View of king post roof along avenue 1 looking north**

The roof is higher than the earlier cast iron roof with an internal glazed gallery above the shopfronts and open clerestory above. Some of the clerestory has been partially enclosed with corrugated iron and plastic horizontal boarding,. The majority of windows in the internal glazed gallery are 6 light top opening casement windows with lamb tongue mouldings that light the upper floor of the shop units.

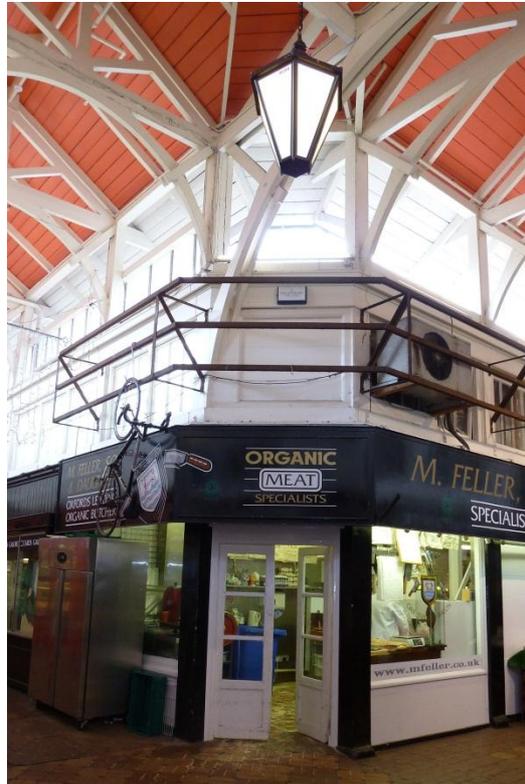
One of the most distinctive features of the historic back to back stalls in this part of the Market are the splayed doorways which survive in part at each corner block.

Fig 22: View of splayed doorway.

Many of the shop front doors have glazed upper panels and solid panels in the bottom half. Above the doorways is a rectangular fascia board with framing to mounted signage. Elsewhere along the Avenues central doorways are used to access shop units. Some of these central doorways have now been blocked and only the beaded architraves or over lights are visible in the shopfront design.

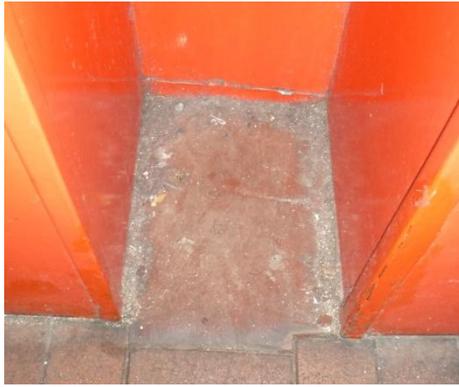
Where timber shopfronts remain, internal roof trusses are pegged into the frame. The pegs are visible externally. A fragment of the late 19<sup>th</sup> century terracotta floor clay tiling, with drainage channel is partially visible in front of No 98 at the northern end of Avenue 3. The existing floor tiles are 20<sup>th</sup> century.

**Fig 23: View of terracotta floor tile under the shop front of No 98.**

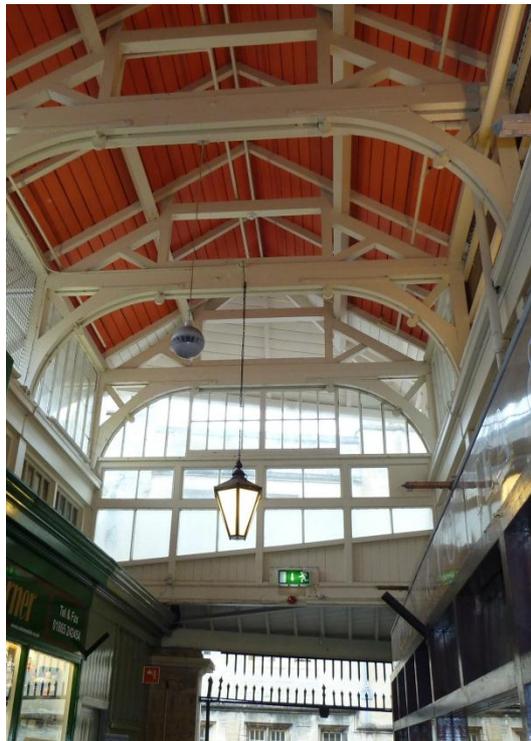
The northern section of avenue 4 is covered by a Queen post roof with arch braces.

**Fig 24: View of queen post roof with braces**

This section of the Market was rebuilt in 1888 following a fire in 1886 and extended north to Market Street in 1898. Along the eastern wall at high level formed by the braces are large timber arches with horizontal timber louvers.

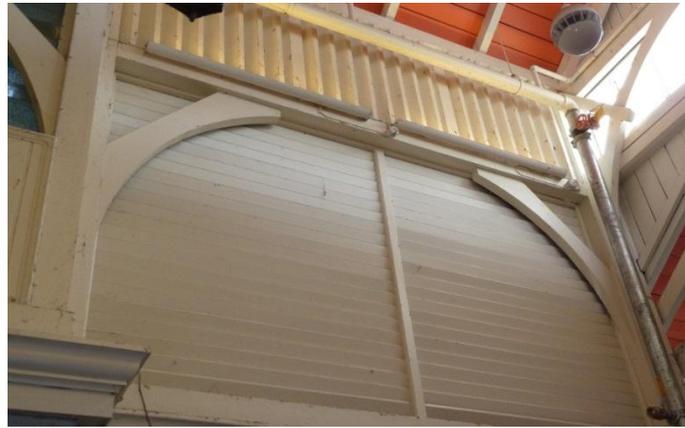
**Fig 25: View of horizontal timber louvers along the east wall of avenue 4.**

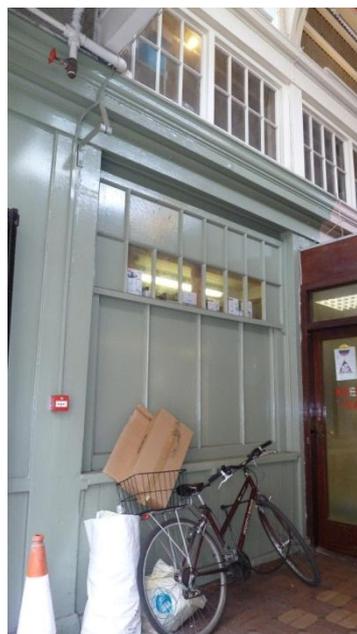
Above the louvers are clerestory windows with mullions and vertical timber louvers. At the northern end of Avenue 4 next to Market Street is the best preserved 19<sup>th</sup> century shop front complete with vertical boarded stall riser and large 19th century top opening sliding sash with horns. The window has 4 large panes on the lower sash with beading. The upper sash is 8 over 8 with 6 glazed panels remaining.

**Fig 26: View of large timber sash with horns**

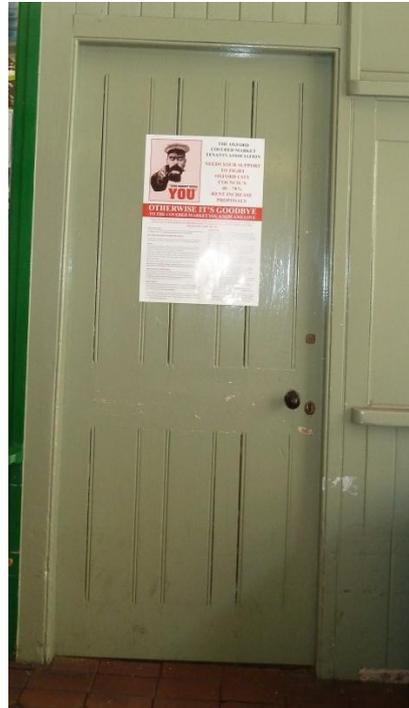
Opposite the window on the western side of Avenue 4 is a 19<sup>th</sup> century timber six panelled door with beaded architrave.

**Fig 27: View of 6 in sized panelled door in avenue 4.**

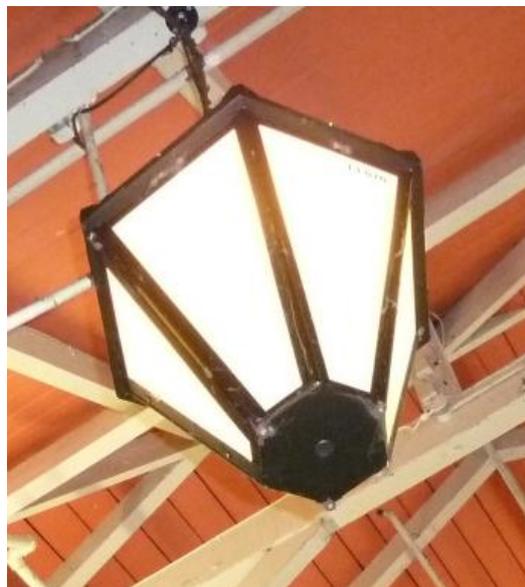
**Fig 28: View of hanging lanterns above avenues 1-4**

Discrete uplighters fixed above cornices provide architectural lighting at high level. Metal octagonal lanterns hung from chains from the roof illuminate the avenues and shopfronts. Most shops also have additional external or internal lighting to illuminate shop windows and signage.

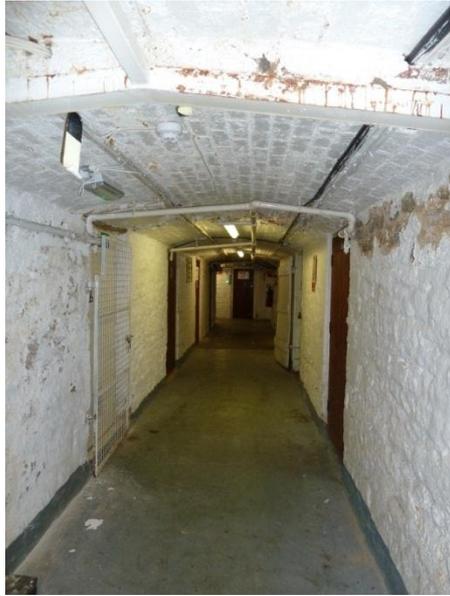
**Fig 29: View of the basement tunnel running north/south**

The cellar is a series of tunnels running north/south and east/west with stone walls and brick barrel vaulting. The tunnels running west/east are now blocked. Along the tunnel are small vaulted chambers set behind locked metal doors. There is graffiti etched into the wall which has been painted over.

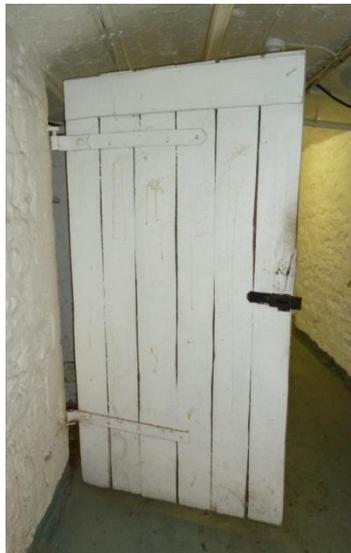
**Fig 30: View of earlier cellar door.**

In front of one of the doors is an earlier 19<sup>th</sup> century planked and battened door with strap hinges.
